Transformer failures within Southern Africa

by L Moodley, K Govender and Y Chinaboo: Doble Engineering Africa

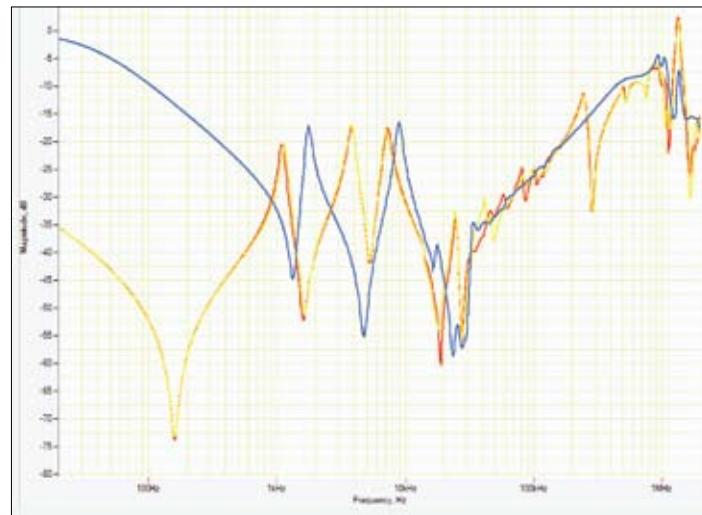
Fig. 1: HV to MV winding response.

- SFRA Tests: The SFRA results are given in Fig. 1. The HV to MV winding open circuit test shows a significant difference in the blue phase compared to the other two phases. This is a result of a possible shorted turn, which has the effect of creating an imbalance in the reluctance on one of the core limbs, producing this characteristic change in low frequency response. Excitation current and ratio tests supported this diagnosis. However, there is also a variance on the blue phase when compared to the other phases in the mid-to-high frequency range, which indicates winding deformation. This variance warranted an internal inspection.

All the electrical tests pointed to a problem possibly limited to the tapchanger. However, the SFRA indicated clear winding/lead deformation on the blue phase. This was the result for the main tank pressure operating.

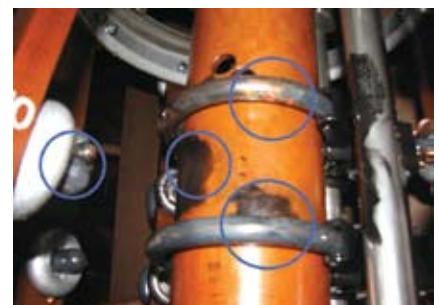
Fig. 3: Blue phase tapping leads and broken cleats.

- Windings in Main tank: Blue phase tapping leads and cleats had severe distortion of the tapping leads external to the windings, due to fault current forces, and paper insulation damage. See Fig. 3. The condition of the MV winding could not be inspected. Numerous cleats and bolts were dislodged and broken and had fallen to the bottom of the transformer.

It was clear that the tap-changer had faulted. If the fault was restricted to the tap-changer, repairs would have been undertaken on site. This could have surely resulted in a further failure as a result of the tap-changer lead movement and damage to the windings as indicated by the SFRA. The transformer is due to be de-tanked and inspected in the factory.

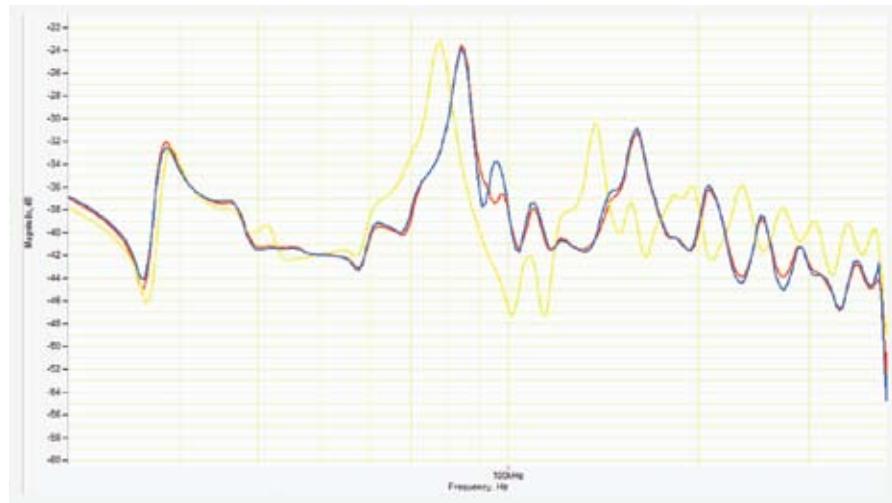
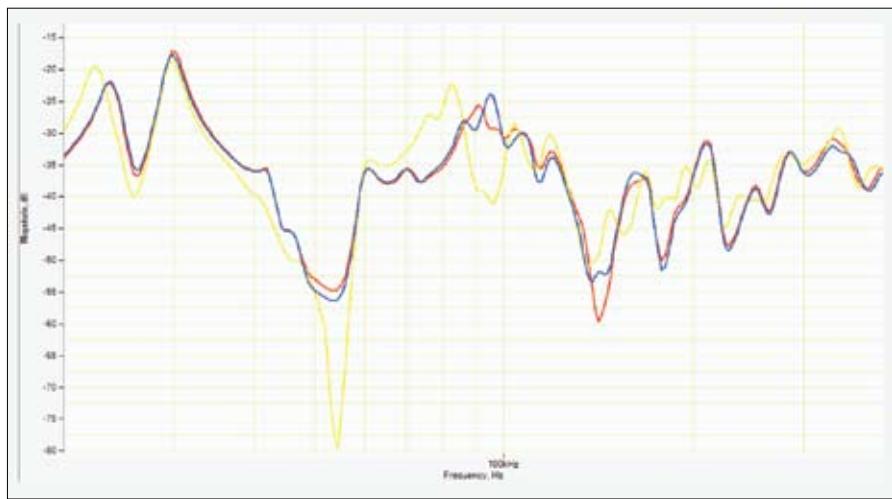
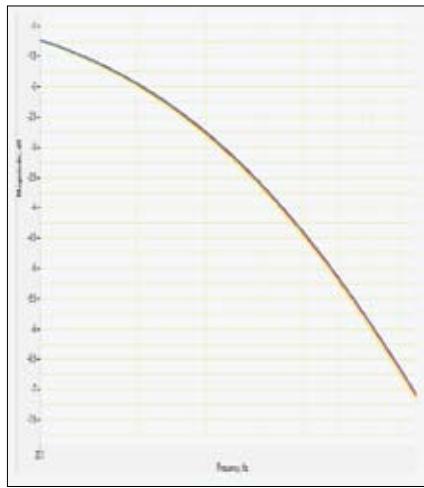
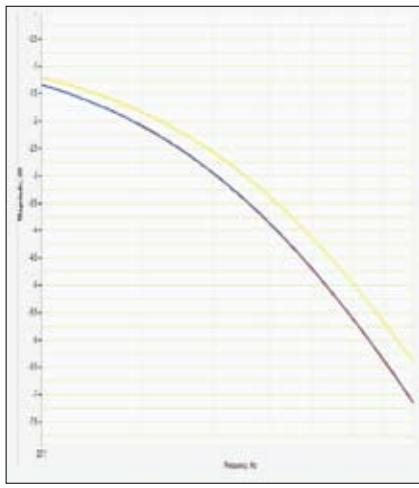
- Power Factor and Capacitance Test: The power factor and capacitance test results were within acceptable limits.
- Ratio Test: The ratio test results were within acceptable limits.
- Excitation Current Test: The excitation currents were within acceptable tests.
- SFRA Test: The results are given in Figs. 4, 5, 6 and 7. The HV to MV winding open circuit response shows clear variances on the middle phase at

frequencies between 20 kHz and 400 kHz when compared to the other two phases, indicating hoop buckling. The MV winding to neutral open circuit response shows similar frequency shifts on the white phase at frequencies between 20 kHz and 400 kHz, indicating deformation in the MV windings. The HV and MV Short Circuit response revealed no resistance or impedance change between the phases. The MV Short circuit test revealed a resistance and impedance change when compared to the other phases, a clear indication that the deformation is restricted to the MV winding.

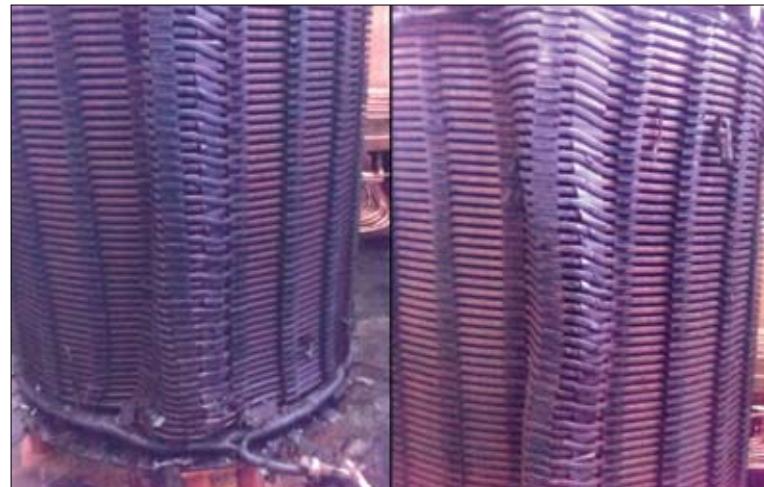
Fig. 8: MV white phase.

The transformer was internally inspected and the MV winding had clear indications of winding deformation in the form of hoop buckling. This is shown in Fig. 8. In this case SFRA proved to be the only test that could detect this type of fault as all other electrical and oil tests gave no indication.

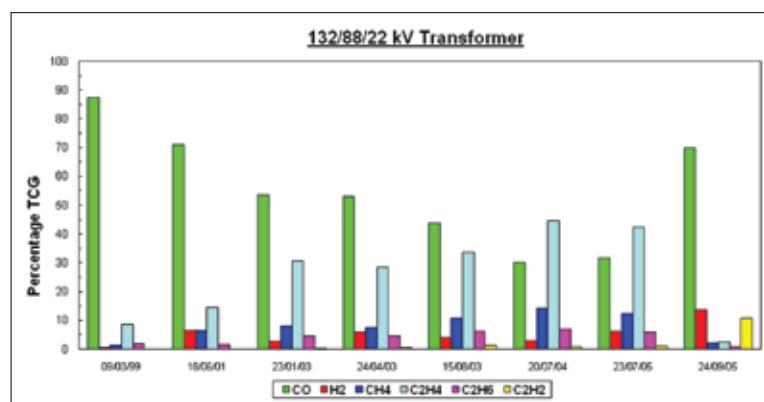
Fig. 9: DGA signatures.

The results are shown in Fig 9. The Doble Algorithm results are shown in Fig 10. From 1999 until 2005 the transformer experienced a localized thermal fault. This is signified by the high levels of ethylene and significant levels of methane and ethane. A DGA signature of this pattern indicates a core and frame to earth circulating current. The transformer experienced a dielectric fault on the 24/09/05. This is indicated by the levels of hydrogen and acetylene. The root cause of the transformer failure was the uncorrected thermal fault that was present since 1999.

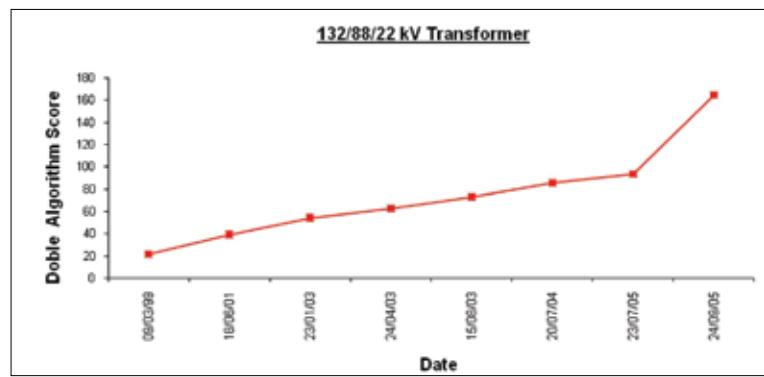
Fig. 10: Doble algorithm scores.

In this case study it is clear that the Doble Algorithm identified the fault many years before the failure, and also indicates a steady increase in the scoring, which indicates a worsening condition.

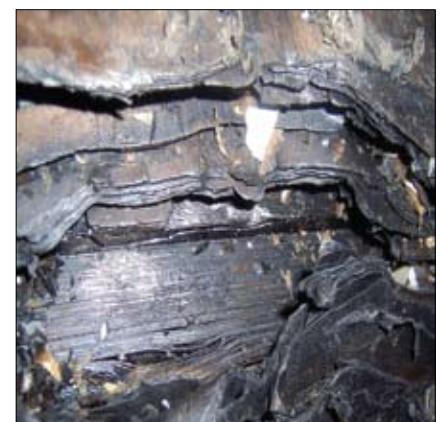
Fig. 11: Uncorrected thermal fault.

After the analysis of the DGA test results, an internal inspection was performed. The results are shown in Fig. 11.

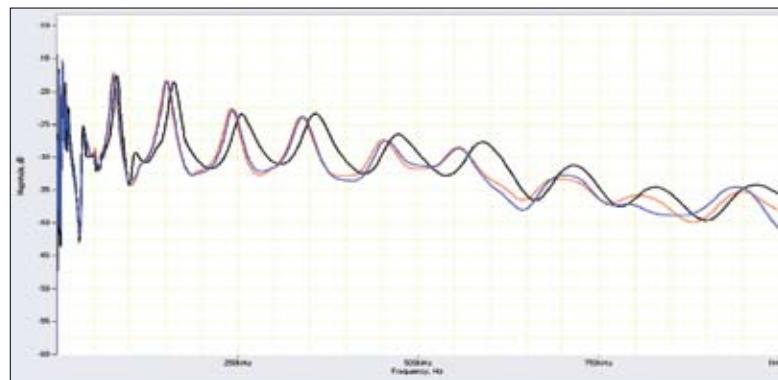
Fig. 13: Axial collapse.

A 132/11 kV transformer, manufactured in 1978, and rated at 30 MVA was taken out of service as a result of a Buchholz alarm. The DGA indicated a dielectric fault possible involving the winding. Apart from having elevated power factor results all other tests did not give a clear indication of the possible problem. The SFRA results showed a significant shift of a number of resonances for the C phase LV winding (Fig. 12). The transformer was removed from service and a tear down was performed. The internal inspection revealed an axial collapse of the C phase of the LV winding (Fig 13).
