Recent Transformer Failures within Eskom Transmission

Nkosenye Sidwell Mtetwa, ESKOM Transmission

Luwendran Moodley, Doble Engineering Africa

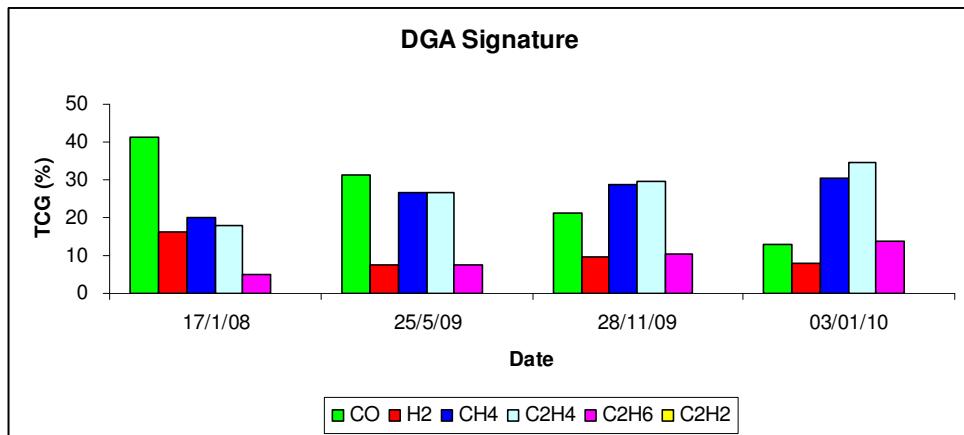
Figure1: DGA Signature for the Transformer

The DGA signature is given in Figure 1 below. The dominant hydrocarbon in the DGA signature is ethylene and methane in similar quantities. The relative levels of these gases indicate a localized thermal fault.

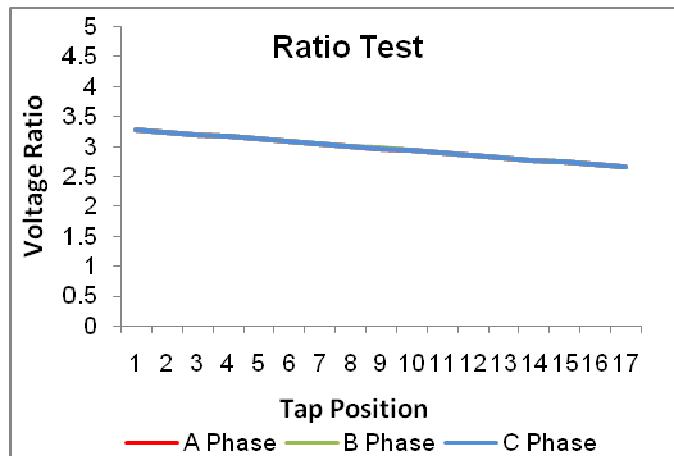
Figure2: Ratio Measurements

The ratio measurements are given in Figure 2 below. The ratio of the transformers was tested at 10kV. The ratio measurements revealed no significant concerns.

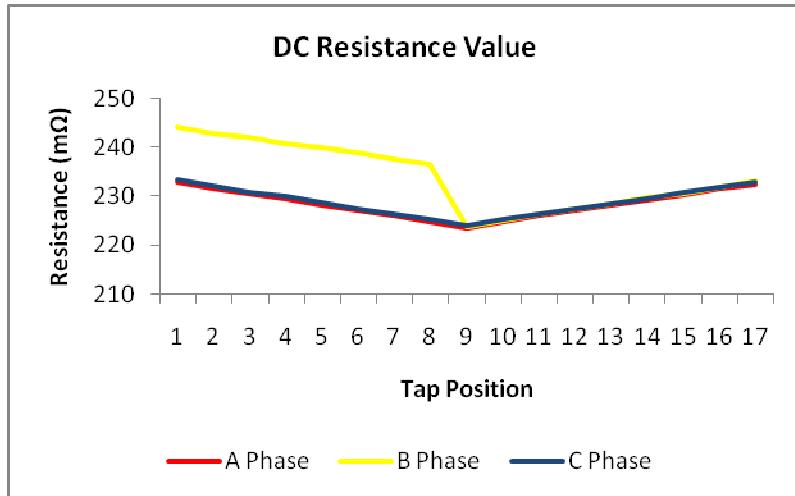
Figure 3: DC winding resistance values

The DC winding resistance test results compare very well between the A and B phase. However, it must be noted that there is an increase in the resistance on the B Phase from tap 1 to 8 when compared to the other two phases, possible the effect of the change over switch within the selector. The MV and tertiary resistance were within acceptable limits.

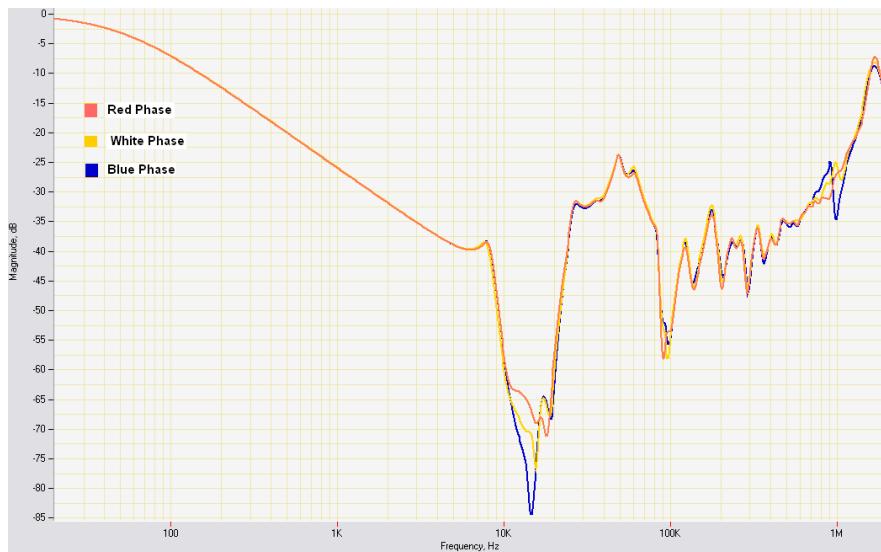
Figure 4: HV Winding to Neutral Short Circuit Response

The short circuit test revealed no difference in the resistance and impedance between the HV winding. The comparison between the phases finds that the responses demonstrate a characteristic pattern and has good correspondence across the entire frequency range. These responses indicate no winding deformation.

There is a clear variance from about 750 kHz to 1 MHz. These variances may allude to the deformation of tapchanger and main winding leads.

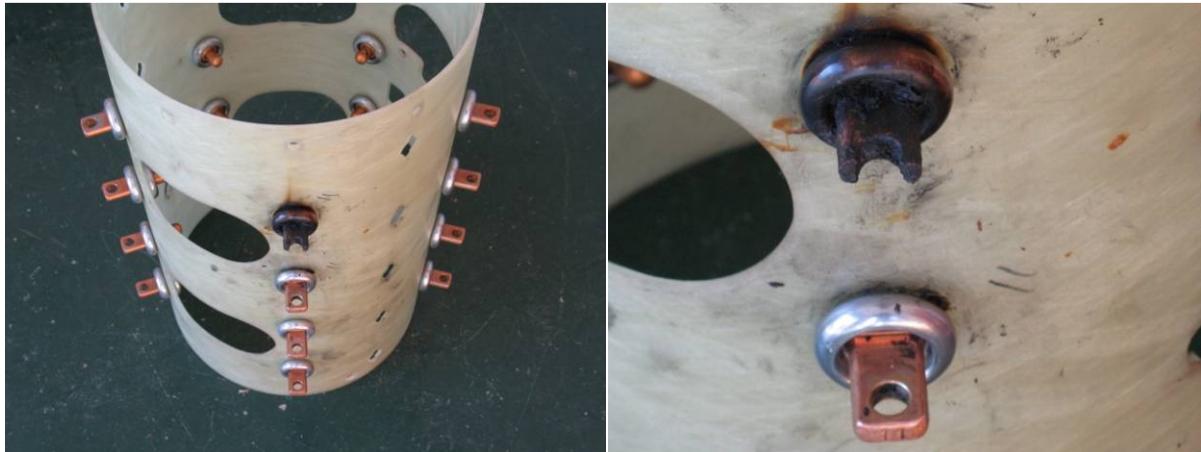
Figure 5: Overheating on the Selector Contact 11.

Based on the DGA and electrical tests it was concluded that the fault was restricted to the tapchanger selector. An internal inspection then followed clearly identified the problem on the tapchanger selector.

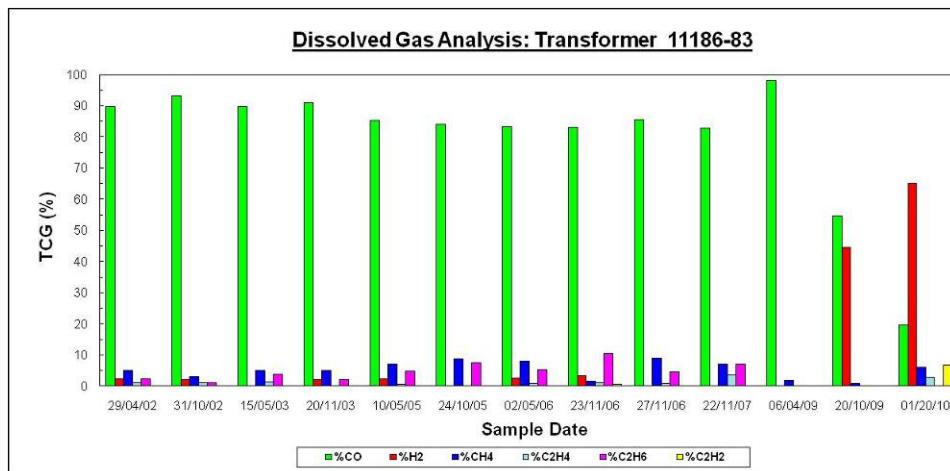
Figure 6: DGA Signature for the Transformer

The DGA signature is indicative of a normal operating transformer up to 06/04/2009. However, the DGA signature on the 20/10/2009 shows a significant increase in hydrogen levels. The DGA signature with this unusually high levels of hydrogen are attributed to a partial discharge type of fault, although low level thermal faults also sometimes have this signature. The DGA signature on the 01/20/2010 shows significant levels of hydrogen, acetylene, and methane. This DGA signature is indicative of dielectric fault.

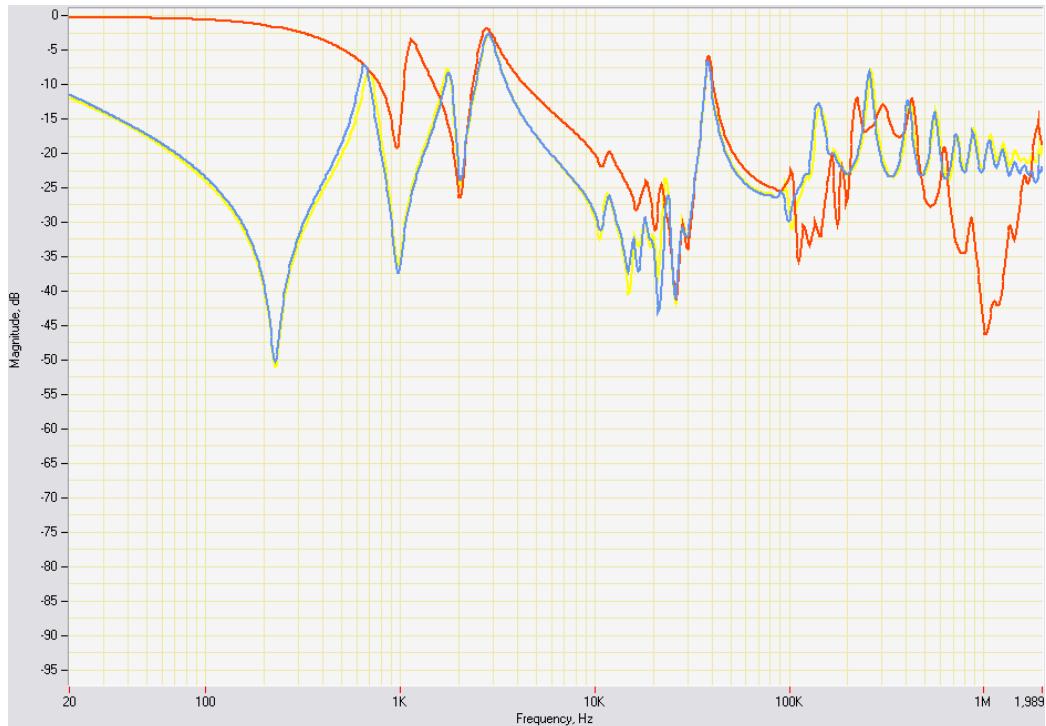
Figure 7: Tertiary Windings Open Circuit Response

There is a clearly a variance on the Red Phase (A Phase) of the winding. This variance is attributed to an imbalance in the reluctance on one of the core limb (A limb). This is indicative of a shorted turn fault that has this effect, which produces this characteristic change in the low frequency response.

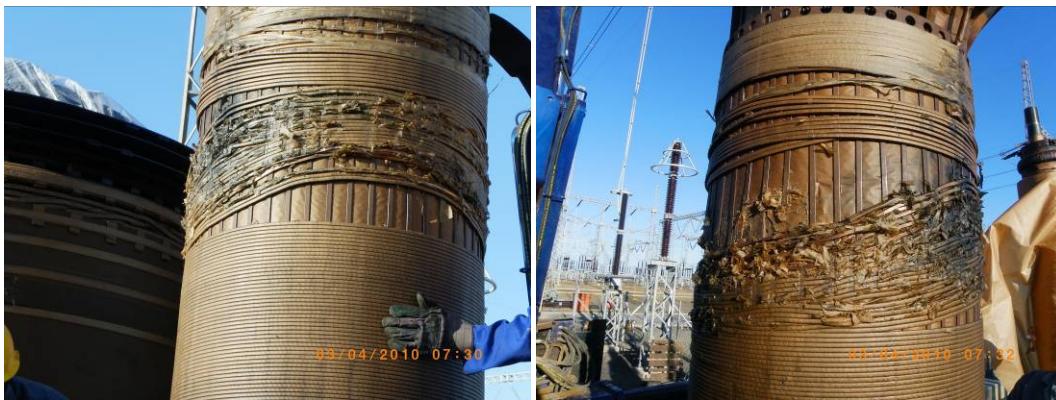
The test results clearly identified a problem with the A Phase Tertiary winding and hence an internally inspection for the transformer is required to assess the damage to the tertiary windings. The transformer was eventually scrapped and during the dismantling, an interturn fault was found on the tertiary winding of the A phase.

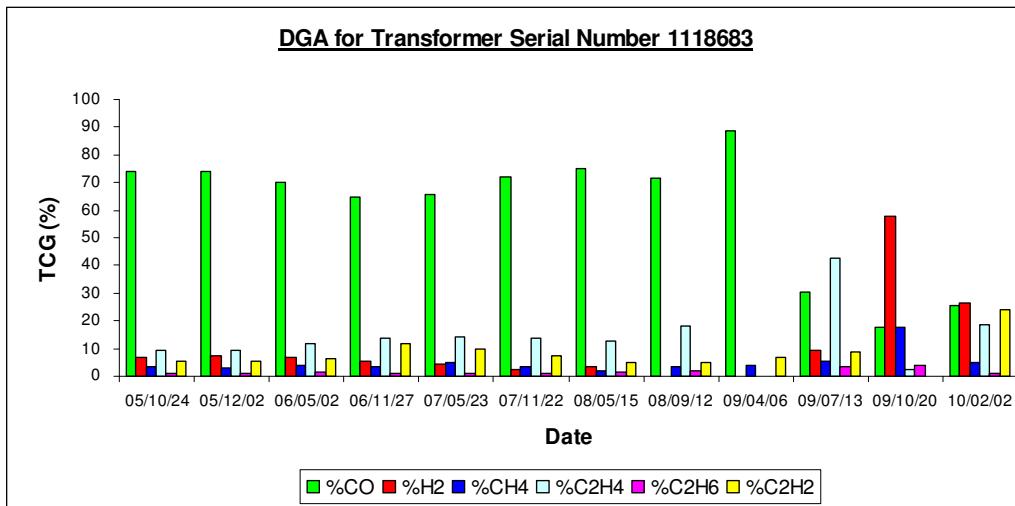
Figure 8: DGA Signature

The DGA signature clearly shows a high level of acetylene for a long period of this Reactor's life. The DGA signature is possibly the result of sparking or arcing between bad connections of different or floating potential eg, winding clamping bolt sparking

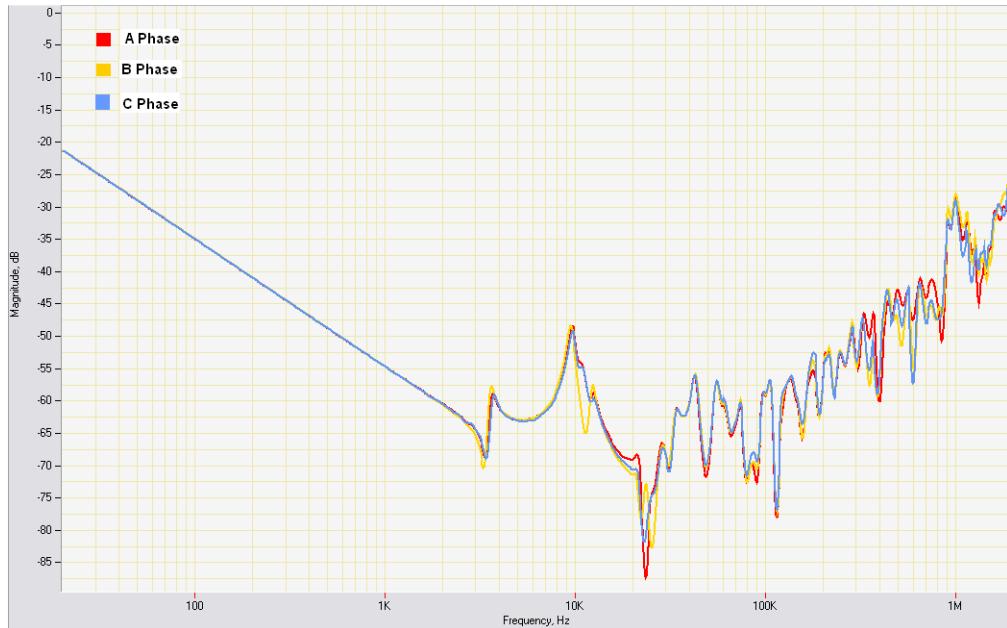
Figure 9: HV Winding to MV Windings Open Circuit Response

All open and short circuit measurements were performed on the transformer. The comparison between the phases finds that the responses demonstrate a characteristic pattern and has good correspondence across the most of the frequency range. These responses indicate no winding deformation.

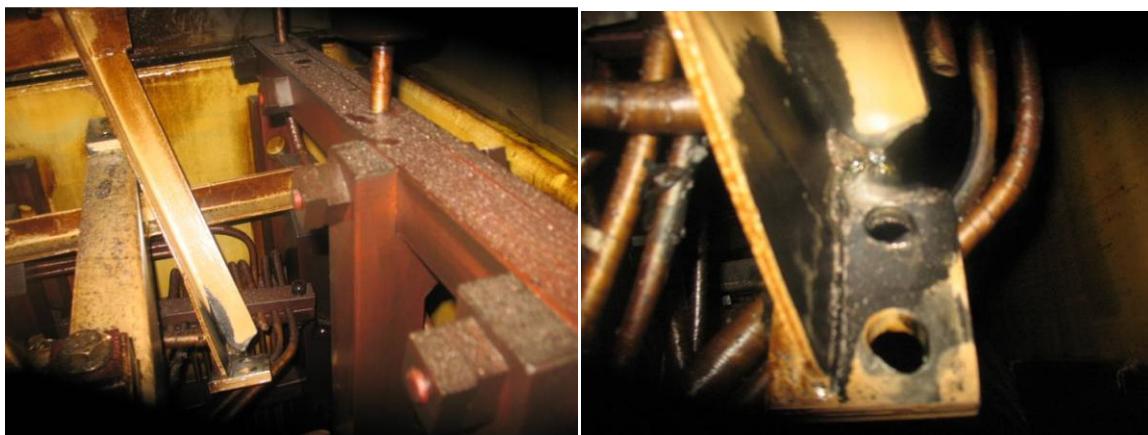
Figure 10: Floating Potential Fault

It was found that one of the brackets that support the tap changer diverter switch barrel had fallen off and damaged one of the selector switch leads (lead number 10). As a result a floating potential was caused by the bracket chopping off the lead.
