TRANSFORMER FLEET MANAGEMENT THE CITY POWER EXPERIENCE

by
S Xulu, City Power
and

Luwendran Moodley and Kamendren Govender, Doble Engineering Africa

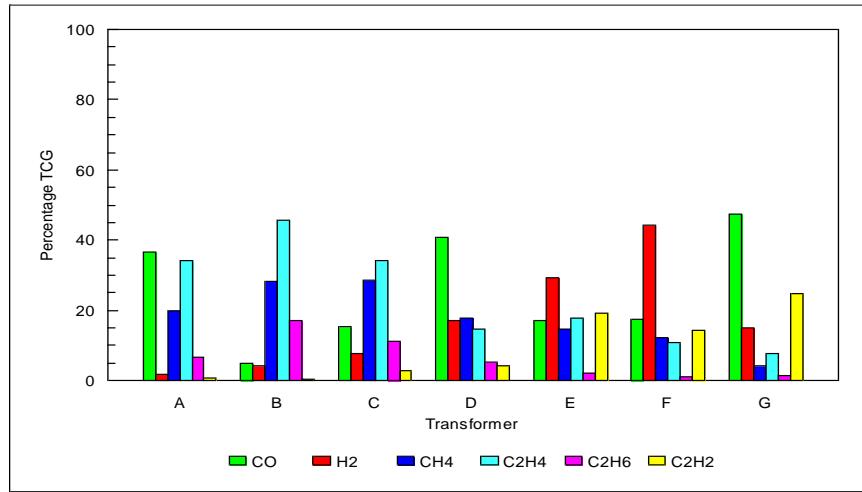
Figure 1: DGA signatures for faulty transformers

A – Core bolt fault

B – Core and frame to earth circulating currents

C – Winding inter-stand fault

D – Winding shorted turns

E – Winding phase to earth fault

F – Winding tracking fault

G – Winding clamping bolt sparking fault

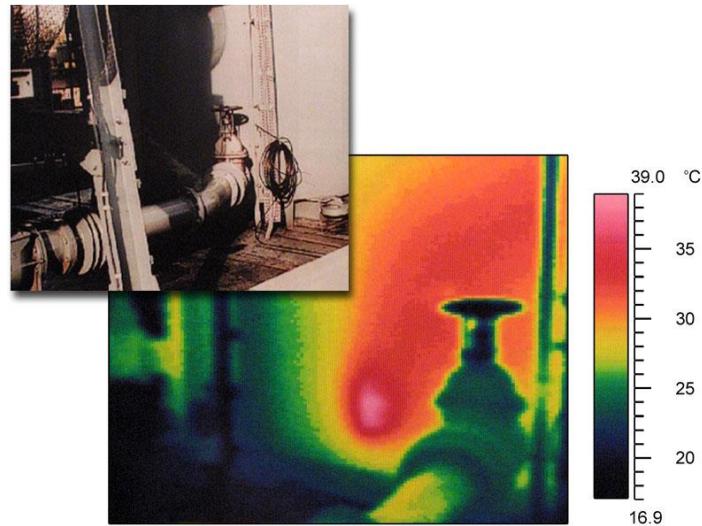
Figure 2: IR scan of a hot spot

Infra-red will indicate external joint issues, bushing tap problems, oil levels in bushings and radiators, blockages in radiators, fan function- it can also indicate tank heating from stray flux, or frame tank circulating current. The figure below illustrates an internal tank hot spot.

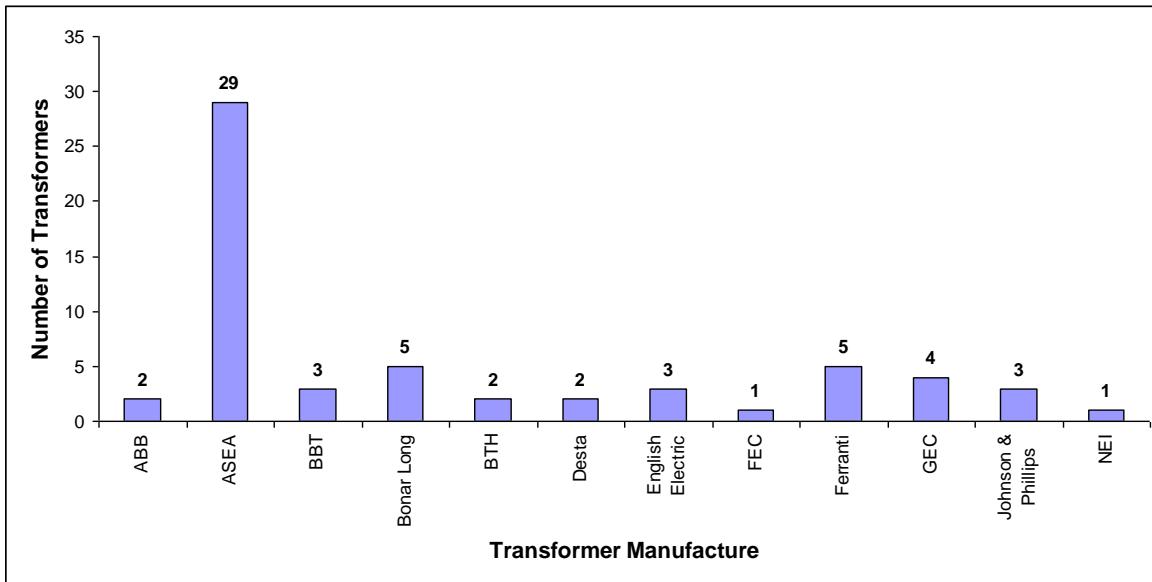
Figure 9: Discharge type Faults

The discharge type faults are the most prominent fault within the transformer fleet. These faults were identified from the DGA and on-site Partial Discharge scanning. The extent of damage that is caused by the partial discharge can only be effectively assessed by performing electrical tests as part of the phase two approach. The figure below illustrates the number of discharge type faults per manufacture. The discharge type faults are prominent on the older transformers.

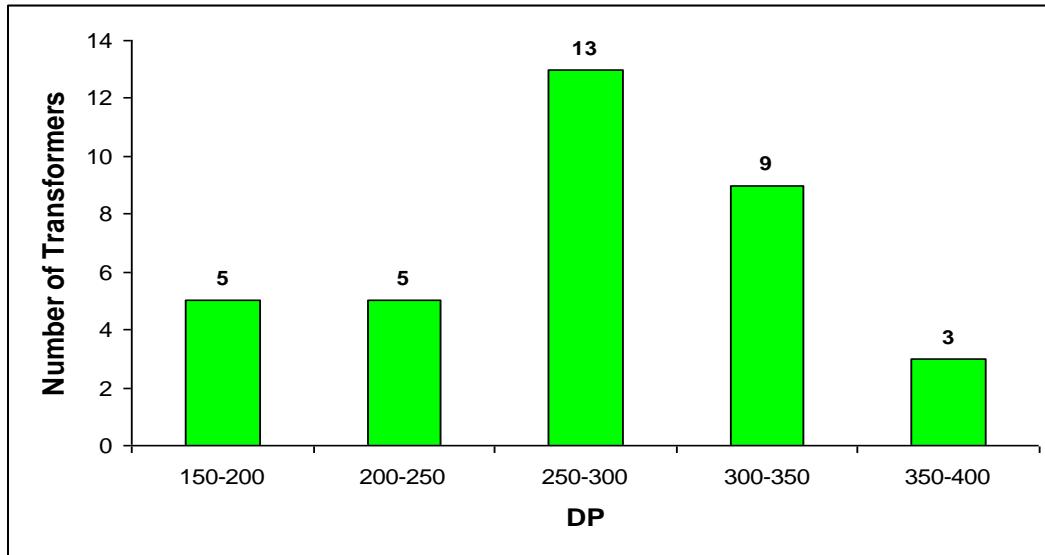
Figure 10: Low DP values for Transformers

Due to the high levels of furans ten transformers (DP from 250 to 150) we would rank the transformer as showing signs of significant ageing and should be considered as an early or immediate candidate for asset replacement. The other twenty five transformers that fall in the range between 250 and 400 would require close monitoring in the form of furan analysis every three to six months (Recommendations are give in the reports).

The ASEA transformers have show to be the most problematic with thirteen transformers showing sign of significant paper aging.

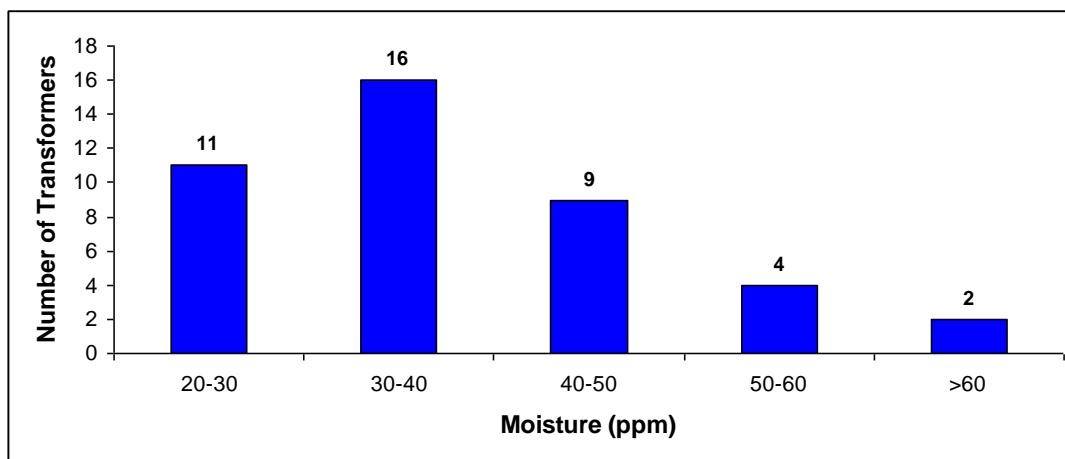
Figure 11: High Moisture Levels for Transformers

Moisture in the insulation influences the life of a transformer in many ways: accelerating aging, increasing losses, reducing insulation strength and introducing the risk of bubble formation during overload. Moisture enters the transformer from the outside from leaks and poor breather systems. However, some of the moisture is developed from within as the oil and solid insulation ages and oxidises over time. When the moisture content of the solid insulation doubles the expected life of the transformer is halved. The figure below illustrates the transformers that have high moisture content. There are a total of 42 transformers that have unacceptable levels of moisture that require urgent purification.

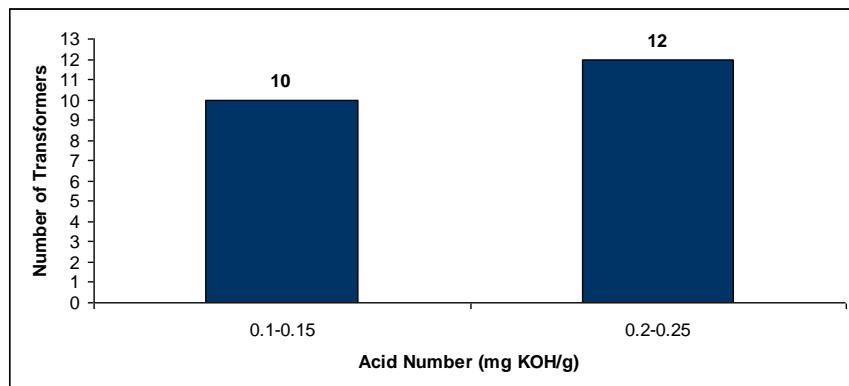
Figure 12: High Acid Number for Transformers

The figure below illustrates the transformers that have high acidity. There are a total of 22 transformers that have unacceptable levels of acidity that require urgent regeneration.

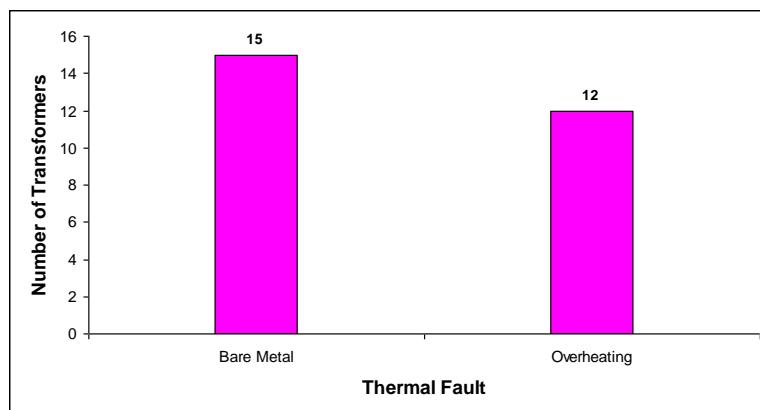
Figure 13: Thermal Faults for Transformers

- (a) circulating current of a 'bare metal' type (bad contacts, eddy currents, stray losses or leakage flux) rather than a covered conductor; and
- (b) overheating/overload fault that is possible the effect of loading issues or poor cooling (possibly blocked cooling ducts, inadequate radiators, and faulty fans) or design related issues.

The figure below illustrates the transformers that fall within the different thermal classes. There are a total of 27 transformers that have thermal faults.
