# TRANSFORMER CONDITION ASSESSMENT AND RECENT FAILURES

by  
Roger Cormack, Eskom Transmission Technology  
and  
Luwendran Moodley, Doble Engineering Africa

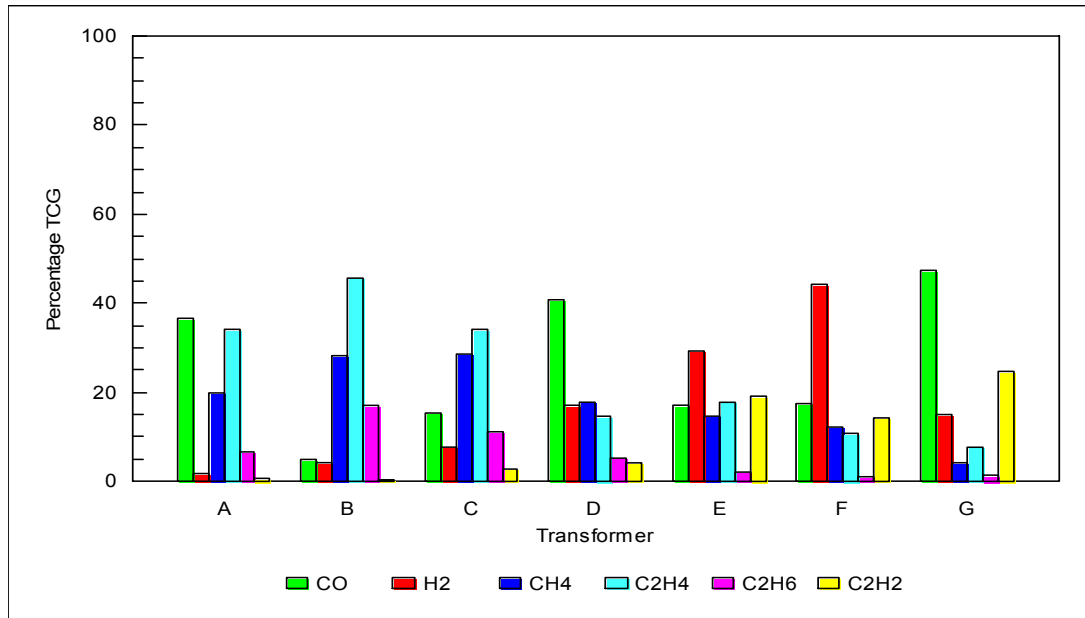
Figure 1: DGA signatures for faulty transformers

Doble has developed an algorithm to mimic the key gas response and gives a single number to track the change in pattern. This method uses the key gas method to present DGA used by IEEE method. The relative proportions of the combustible gases CO, H<sub>2</sub>, CH<sub>4</sub>, C<sub>2</sub>H<sub>4</sub>, C<sub>2</sub>H<sub>6</sub> and C<sub>2</sub>H<sub>2</sub> are displayed as a bar chart to illustrate the gas signature. The novel aspect of the approach proposed here is that this method is used to investigate and illustrate the clear difference that exists between 'normal' and 'abnormal' results. By contrast, in the IEEE Guide four examples of faults are given, but there is no guidance on what a normal result would look like. The DGA score reflects the seriousness of the signature. DGA results for normal transformers would be expected to return a score of no more than about 30, whereas a core circulating current would rate about 60 and more serious problems would score around 100.

- A – Core bolt fault
- B – Core and frame to earth circulating currents
- C – Winding inter-stand fault
- D – Winding shorted turns
- E – Winding phase to earth fault
- F – Winding tracking fault
- G – Winding clamping bolt sparking fault

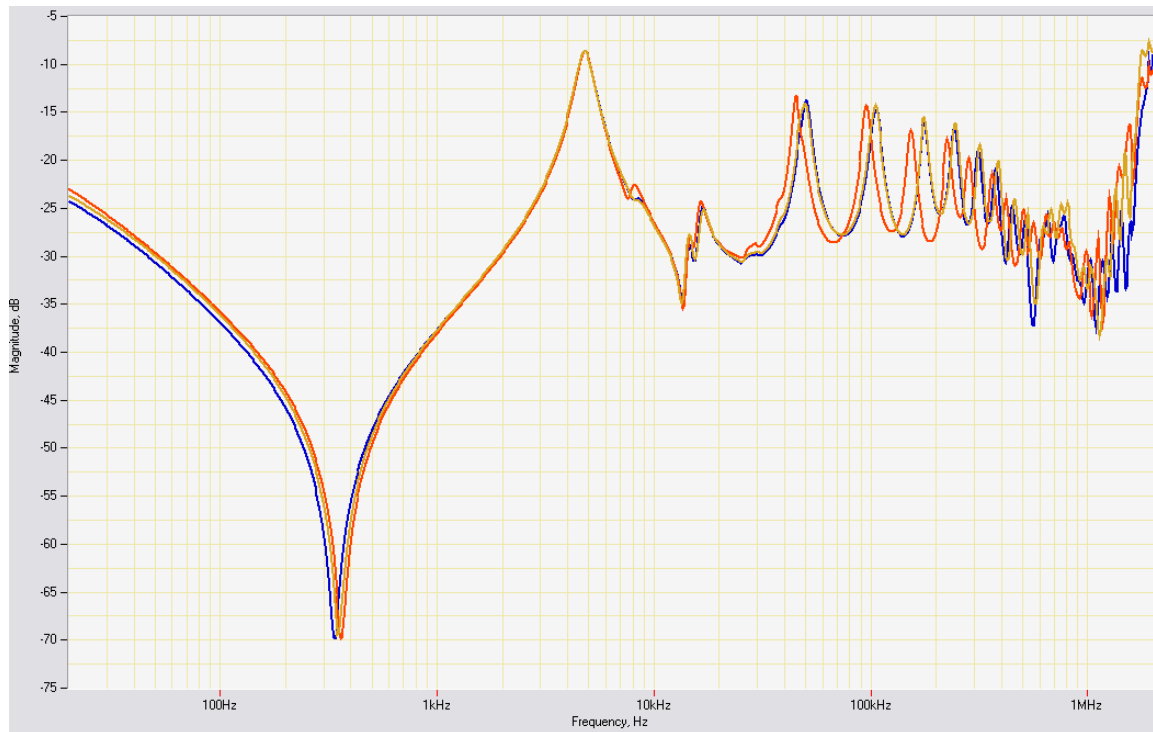
### **Substation E – Serial Number 61**

The comparison between the phases finds that the responses demonstrate a characteristic pattern and has good correspondence across most of the frequency range for the White and Blue phases. The responses for the Red and White phases do not indicate winding deformation. However, there is a very noticeable frequency shift on the Red phase. This shift is typical of a hoop buckling. The frequency shift on the Blue phase is indicative of winding deformation.

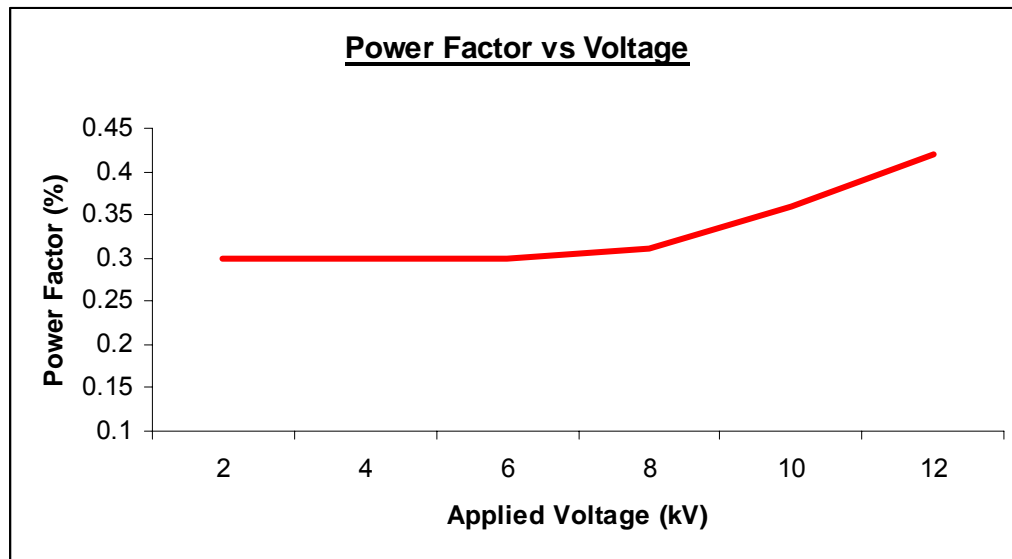
It is clear that the power factor values display a characteristic tip-up that is indicative of possible ionization with the degradation of paper/oil insulation system. This deterioration can be attributed to the corrosive sulphur.

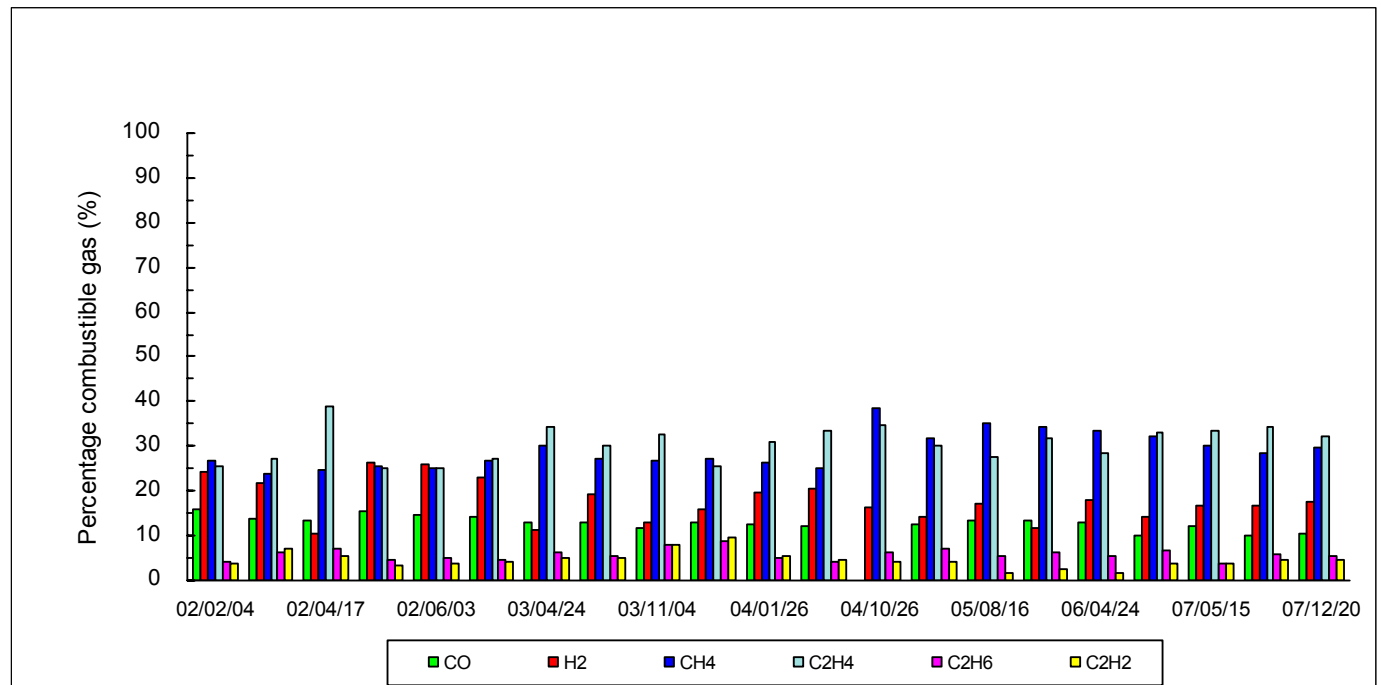
#### Dissolved Gas Analysis

The dominant hydrocarbon in the DGA signature is ethylene and methane in similar quantities with high levels of hydrogen. The relative levels of these gases indicates a localized thermal fault possibly a 'covered conductor' type problem eg. winding fault. Further, the ratio of CO and CO<sub>2</sub> indicates possible involvement of paper.

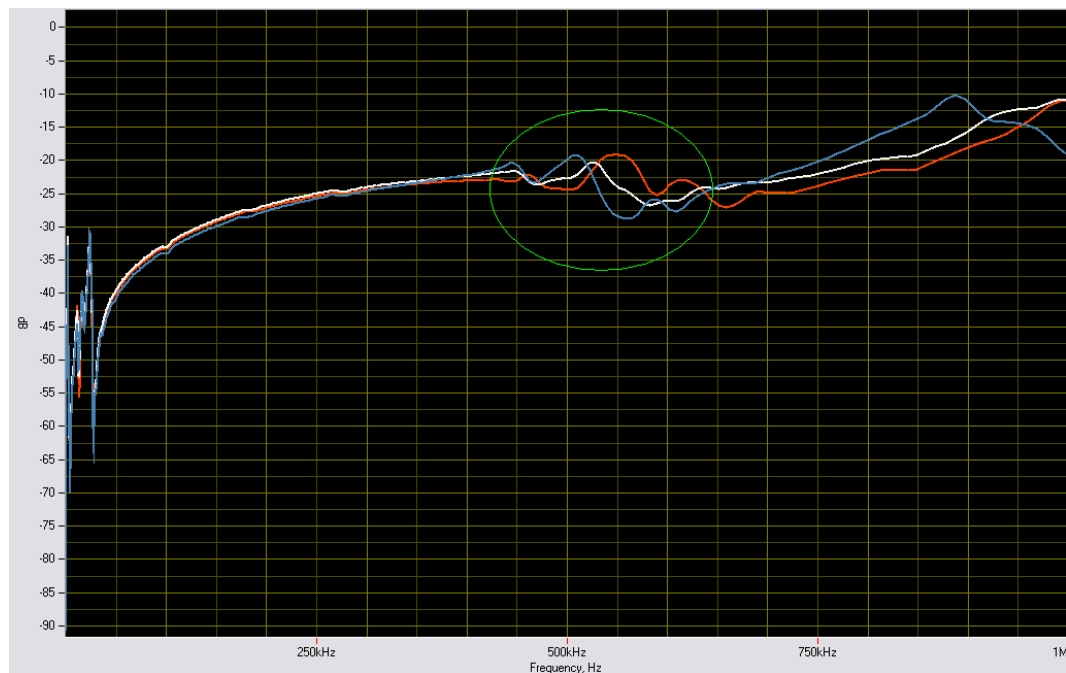
This transformer failed in service and was tripped by pressure relay. The DGA showed clear indication of an internal flashover. Only SFRA was performed on this unit as the DGA results already warranted an internal inspection.

SFRA response clearly showed deformation of the tap leads.

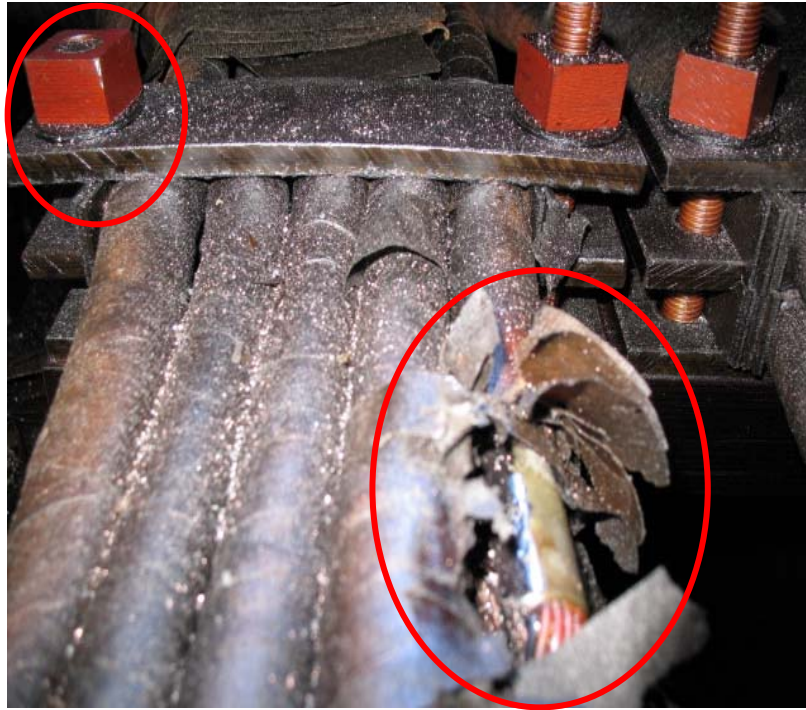
An internal inspection revealed that there was severe damage to the tap lead. As a result of this damage it was recommended that the tap windings responses be measured to assess the condition. The figure below clearly identifies tap winding deformation. The fault that started on the tap leads resulted in the collapse of the tap winding.
