ANALYSIS OF TRANSFORMER FAILURES AT ETHEKWINI ELECTRICITY

**Brian de Klerk - eThekwin Electricity
Kamendren Govender - Doble Engineering Africa
Sunil Govender - Trans-Africa Projects
Luwendran Moodley - Doble Engineering Africa**

ABSTRACT

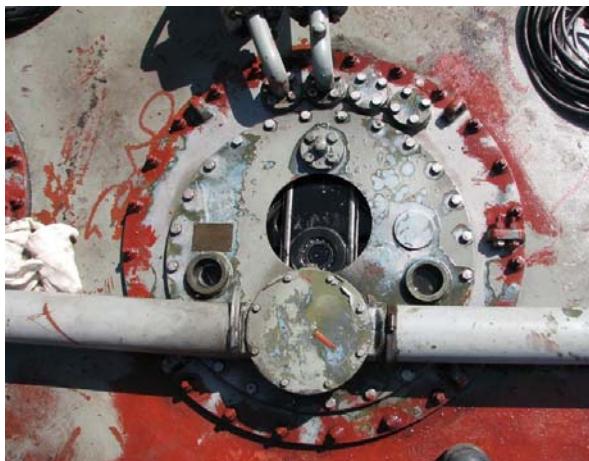
At the initial site inspection, the blue phase pressure relief plate was found to have been blown out from the diverter head cover (see **Figure 1**) and landed on the ground, about 5 metres away. The main tank pressure relief valve had operated (see **Figure 2**). No other external damage was visible.

Figure 1: Pressure relief plate blown out from B phase diverter head cover

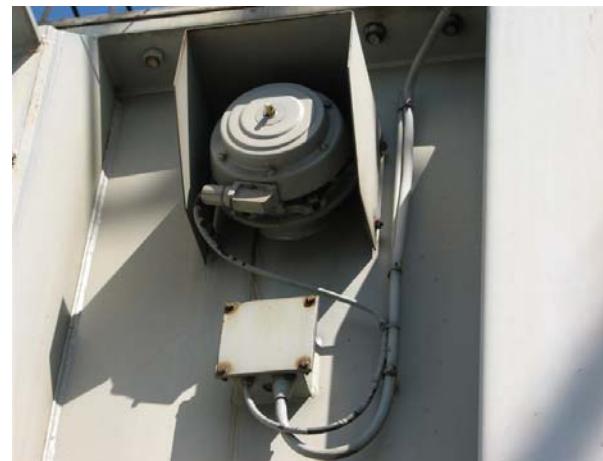
Figure 2: Main tank pressure relief valve operated (yellow pin sticking out)

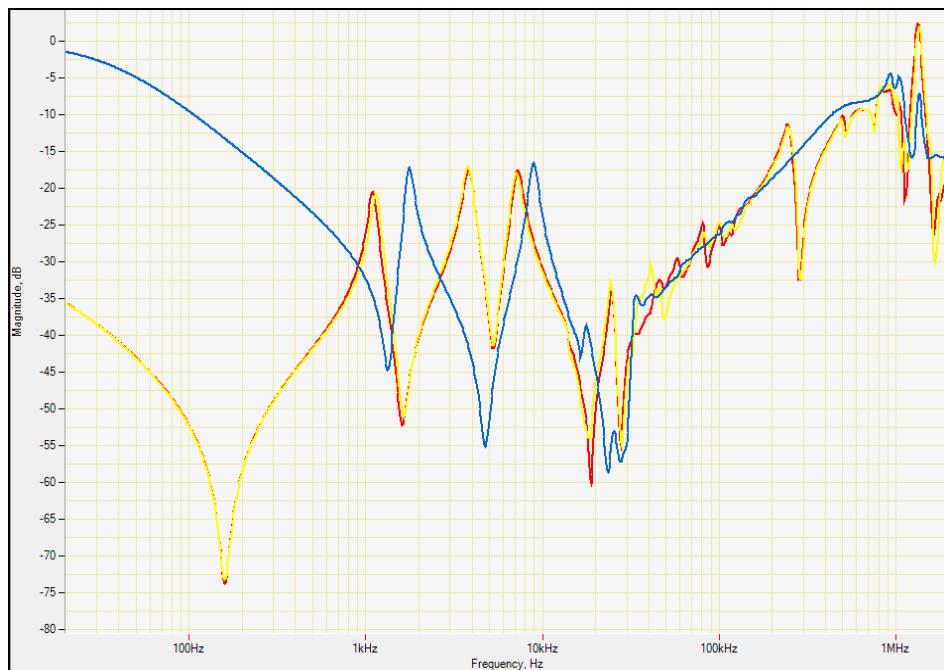
There is clearly a significant difference in the Blue phase when compared to the other two phases. This is a result of a shorted turn failure. A shorted turn has the effect of creating an imbalance in the reluctance on one of the core limbs (in this case the blue trace), which produces this characteristic change in the low frequency response. Excitation current and ratio test supported this diagnosis.

However, there is also a variance on the Blue phase when compared to the other phases in the mid to high frequency range. This variance is indicative of winding deformation. This variance warranted an internal inspection.

Figure 3: HV to MV winding response

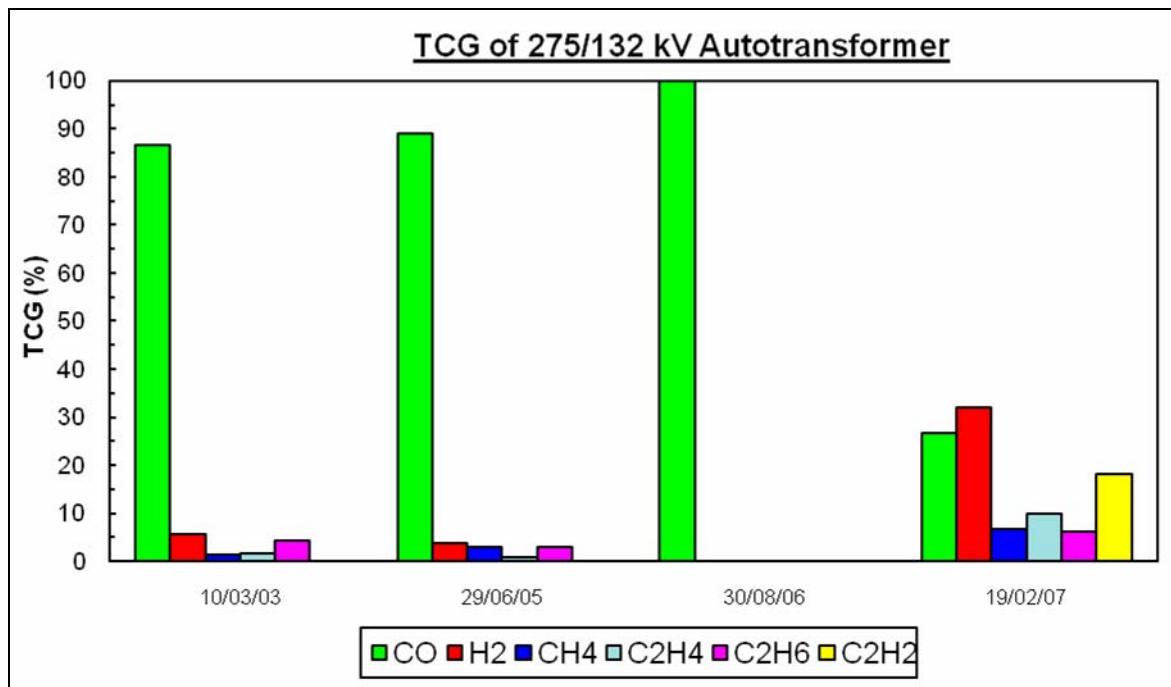
Figure 4: DGA Signature

The DGA signature for this transformer indicated normal operation. Oil purification was performed on the 30/08/2006. The oil purification was performed after diverter maintenance and modification. In hind sight at least one more oil sample should have been performed at the diverter maintenance. The DGA signature of the failure is typical of a dielectric fault.

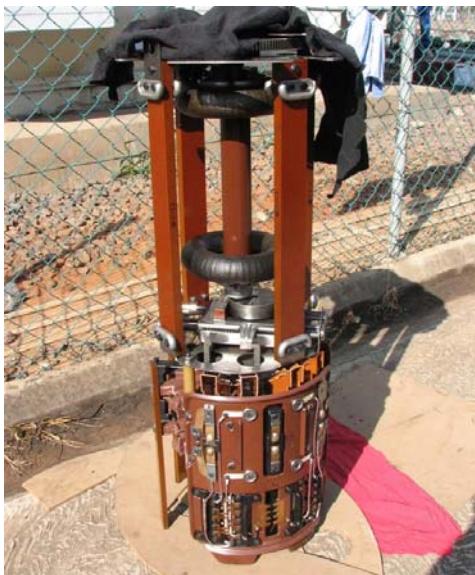
The following damage was found on the blue phase diverter, which is shown in Figure 5 when removed from the transformer:

- i. Blown out pressure relief plate incorporated in the head cover casting.
- ii. Burnt flexible lead which connects metal parts to the common contacts which connect to the take-off terminal. See Figure 6.

Figure 5: Blue phase diverter

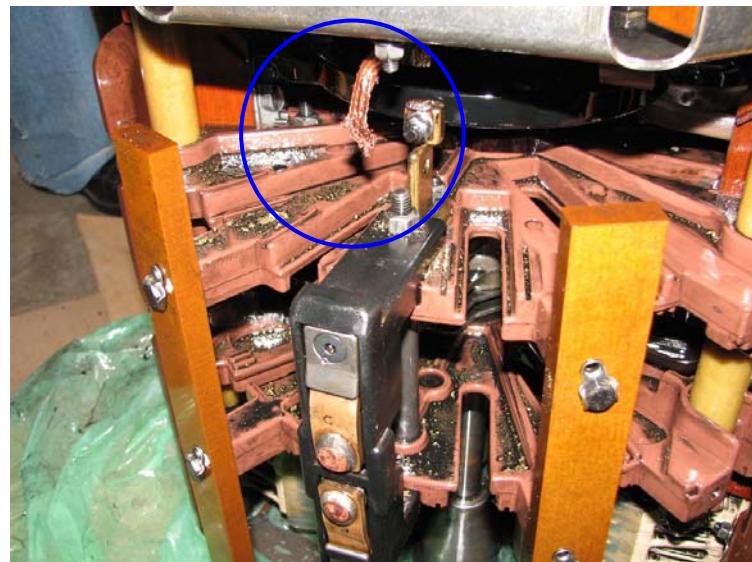
Figure 6: Blue phase diverter- Flexible lead burnt

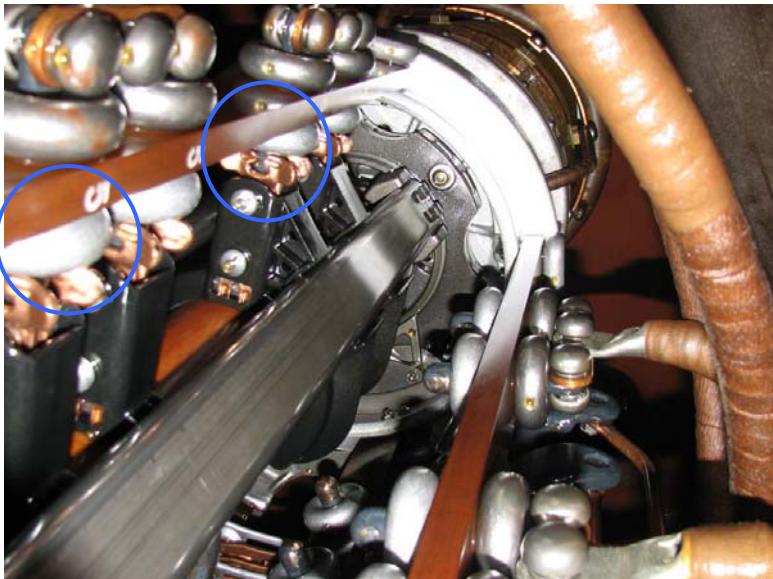
- i. Moving contacts connected to terminals 5 and 6 on blue phase, (tap positions 3 and 4 respectively, whereas these are on terminals 6 and 7 on red and white phases, (taps 5 and 6). See Figures 7 and 8.
- ii. Severe burns due to flashover and arcing of fixed contacts and collector rings. See Figure 9.
- iii. Broken insulating supports. See Figure 10.

Figure 7: Blue phase selector- terminals 5 and 6 connected

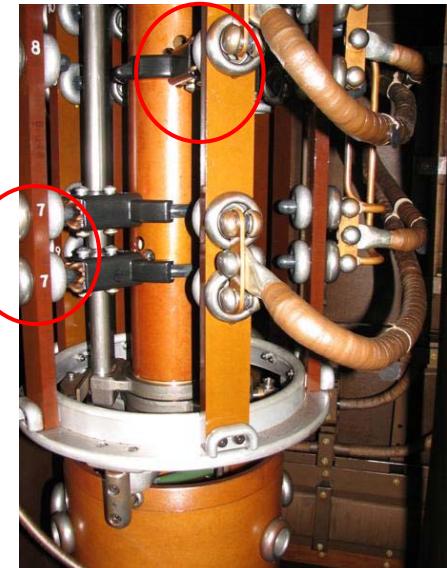
Figure 8: Red phase selector- terminals 6 and 7 connected

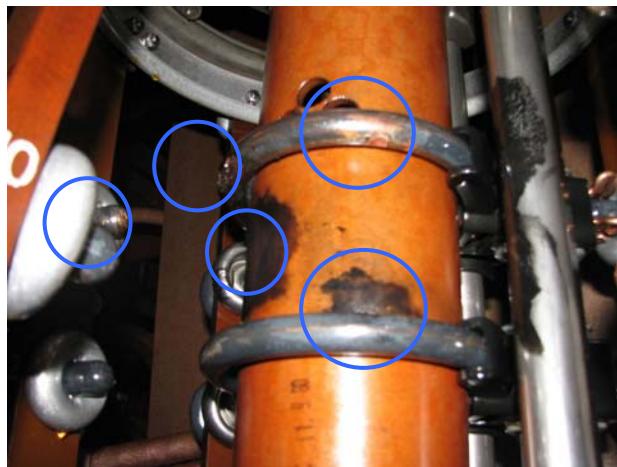
Figure 9: Flash marks on fixed contacts and collector rings

It is clear that there was a flashover at the Blue phase selector, which partially burnt: (1) a shield cap for a nut at the changer over switch, (2) a fixed contact, and (3) a collector ring. Since the oil appeared clean, the flashover would have been caused by an over-voltage, and this would have originated from either: (1) an external source, or (2) a problem in the Blue phase winding. The operating and support metal parts in the selector and diverter are linked via the metal operating shaft. Hence the fault current in these items in the selector flowed to the diverter and then to the common terminal which caused the flexible lead to burn off (see figure 6). This is further supported by the fact that a potential strap in the diverter chamber was also burnt off. These resulted in the overpressure in the diverter.

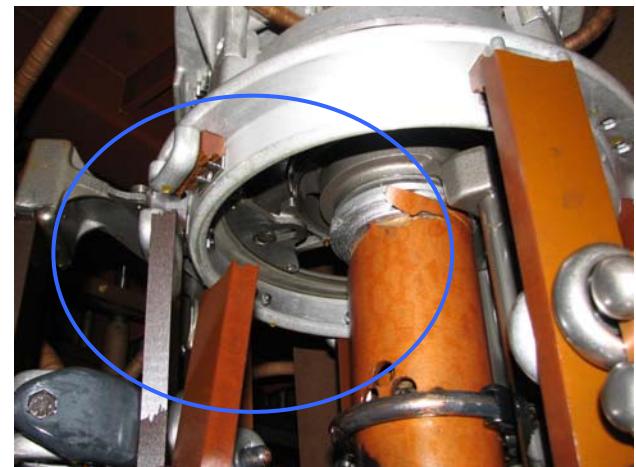
Figure 10: Broken insulator supports

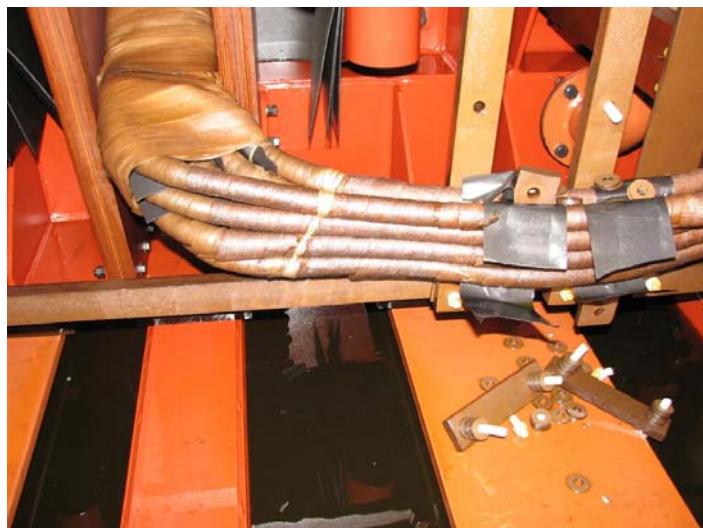
- i. Blue phase tapping leads and cleats: Severe distortion of the tapping leads external to the windings due to fault current forces, and paper insulation damage. See Figure 11.
- ii. Numerous cleats and bolts were dislodged and broken and fell to the bottom of the transformer.

Figure 11: Blue phase tapping leads and broken cleats

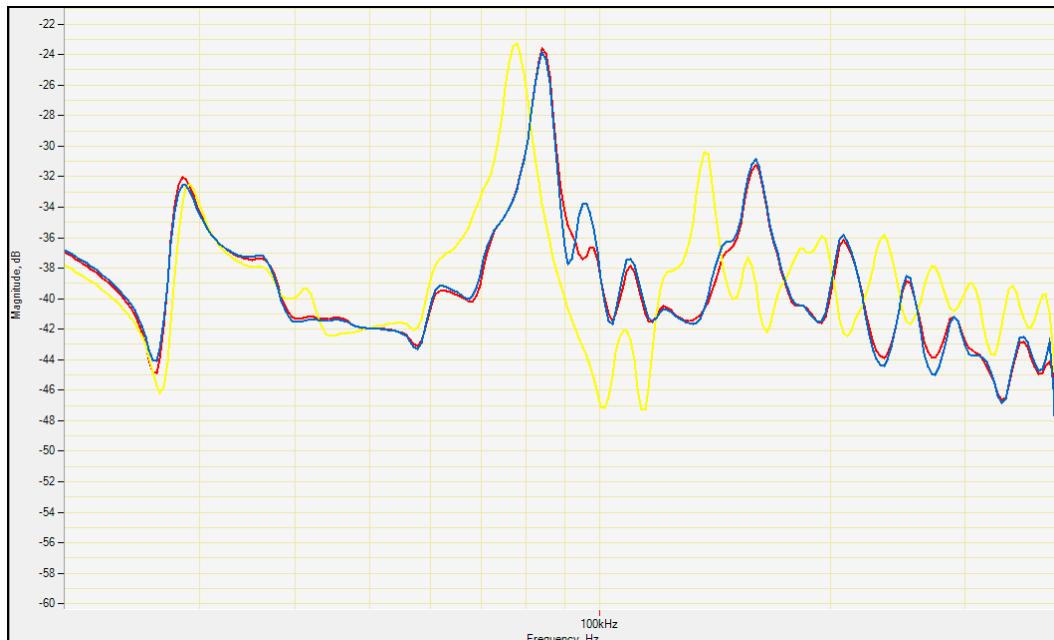
There are clear variances on the middle phase at frequencies between 20 kHz and 400 kHz when compared to the other two phases. There is a clear frequency shift in the middle phase. These frequency shifts are indicative of hoop buckling.

Figure 12: HV to MV winding response

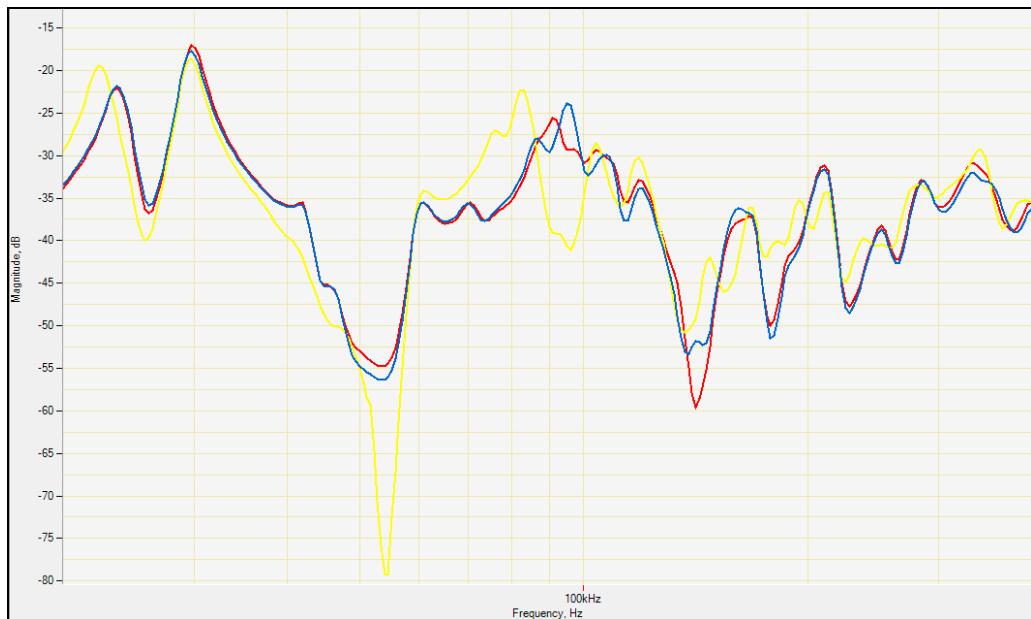
Very similar frequency shifts are evident on the white phase at frequencies between 20 kHz and 400 kHz when compared to that identified on the HV winding. These frequency shifts are indicative of deformation in the MV windings.

Figure 13: MV winding to neutral response

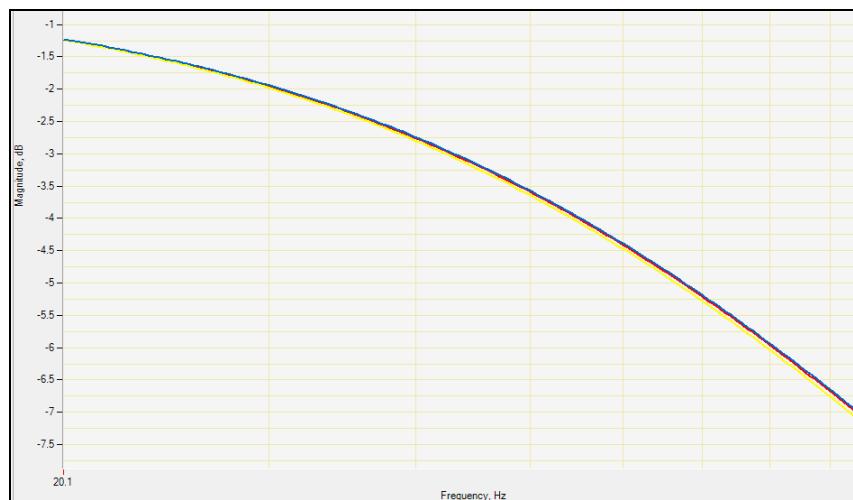
Figure 14: HV Short circuit response

The HV Short circuit test revealed no resistance or impedance change between the phases.

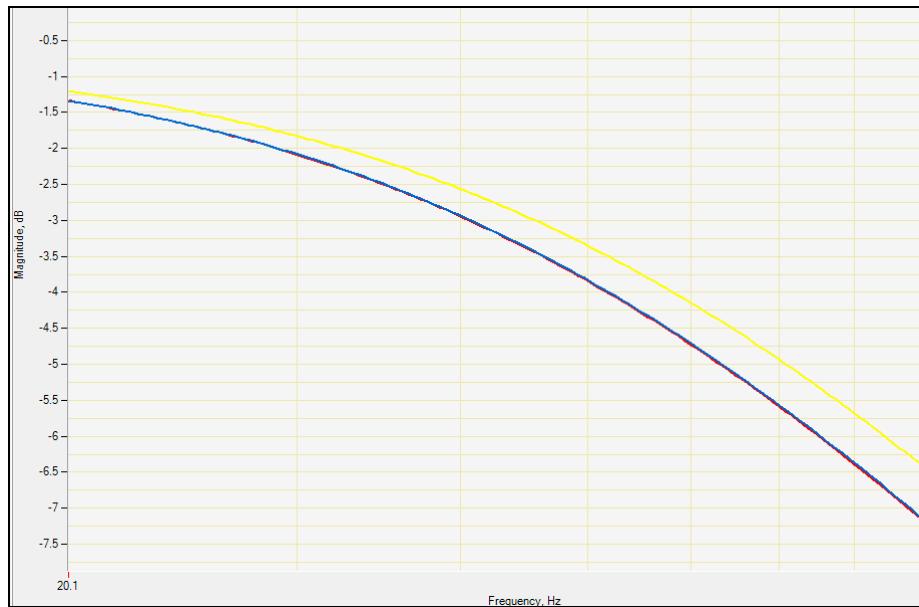
Figure 15: MV Short circuit response

The MV Short circuit test revealed a resistance and impedance change when compare to the other phases. This is a clear indication that the deformation is restricted to the MV winding.

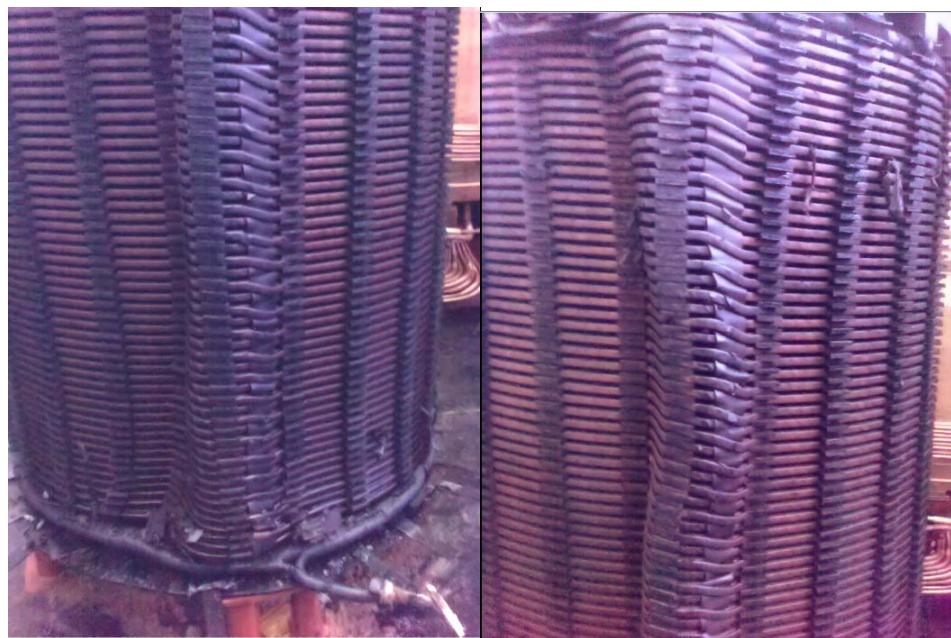
The SFRA revealed MV winding deformation possible a hoop buckling condition. Upon inspection the following was noted as shown in **Figure 16**.

Figure 16: MV White Phase

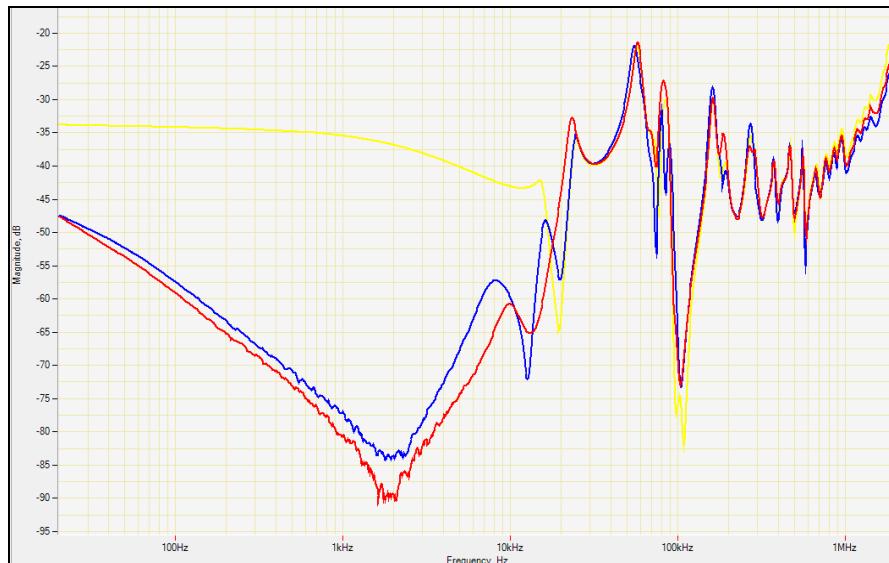
The responses clearly indicate a problem on the White phase.

Figure 17: HV to MV winding response

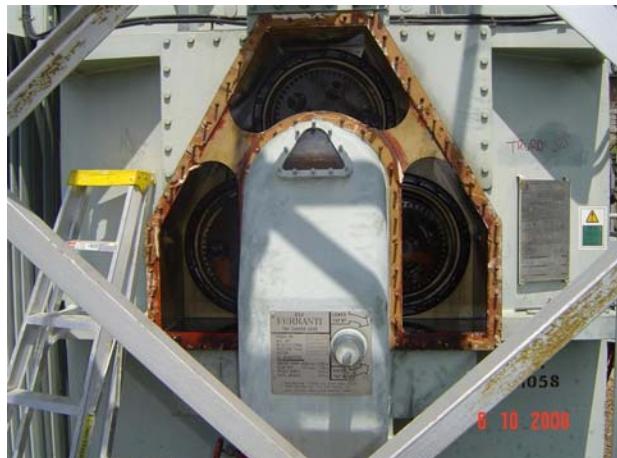
The inspection results are given in Figures 18, 19 and 20. There was a clear indication of a flashover between the red phase and ground. This flashover caused damage to the spur gears, as shown in Figures 20 and 21. There was excessive carbonization of the oil and significant sludge buildup.

Figure 18: View of the Ferranti DS2 tap changer with cover removed

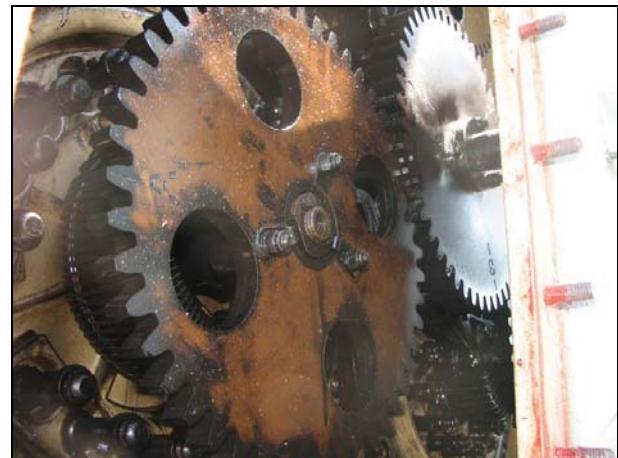
Figure 19: Flashover from Red phase current collector to ground via "insulating" gears.

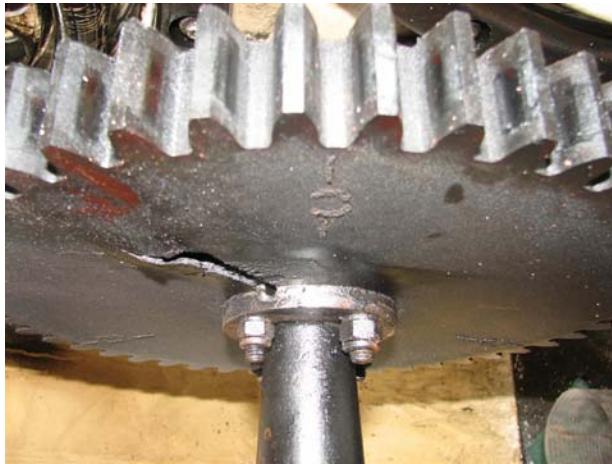
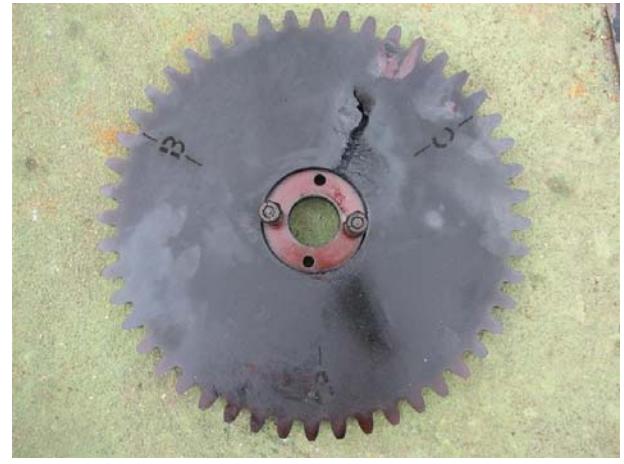
Figure 20: Damaged main gear

The repairs involved replacement of the fixed and moving contacts, and the damaged gears. On-site oil purification was also performed. The SFRA result after repairs is shown in **Figure 21**. The results showed that the problem was remedied. The transformer was subsequently switched on.

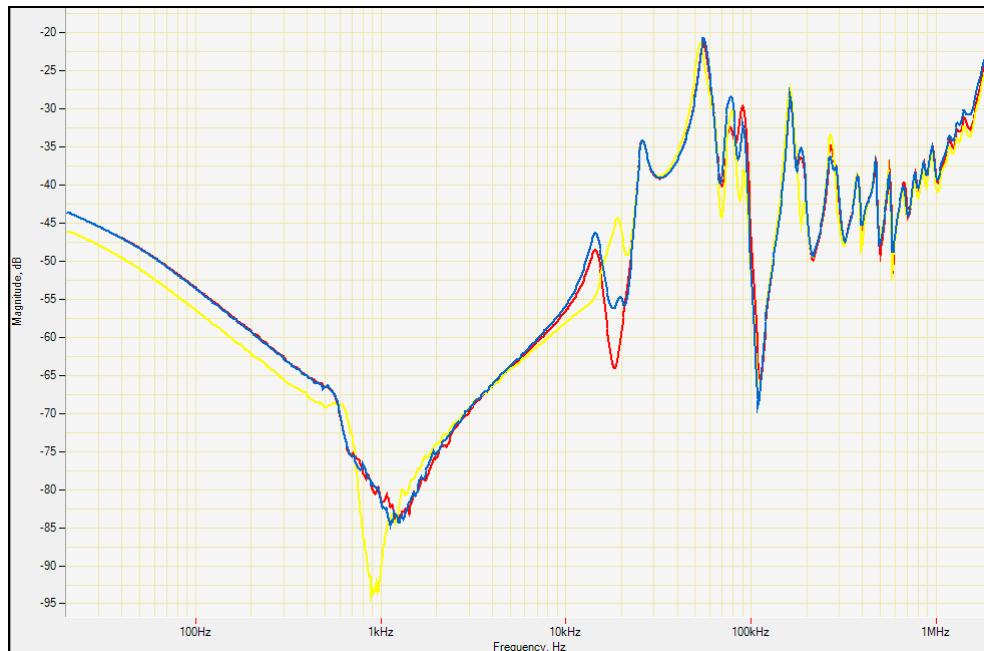
Figure 21: SFRA after repairs to tap changer

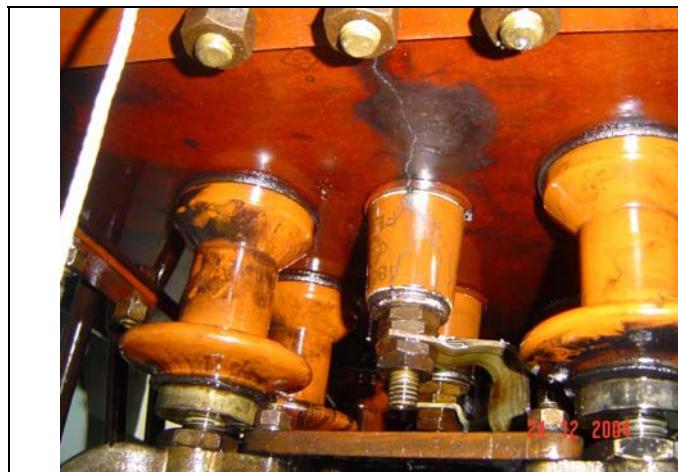
A 33/6.6 kV 15 MVA Dy11 transformer, manufactured in 1963, tripped on earth fault in December 2004. The fault was traced to a flashover in the diverter. The extent of the fault is shown in **Figure 22**, and repaired as shown in **Figure 23**. Diagnostic tests were performed on 12 January 2005. The test results were found to be acceptable and the transformer was subsequently put back into service. The transformer tripped in March 2005. Various diagnostic tests were performed just after the fault, in particular the exciting current test. The results are given below.

Figure 22: Flashover in diverter- phase to earth fault

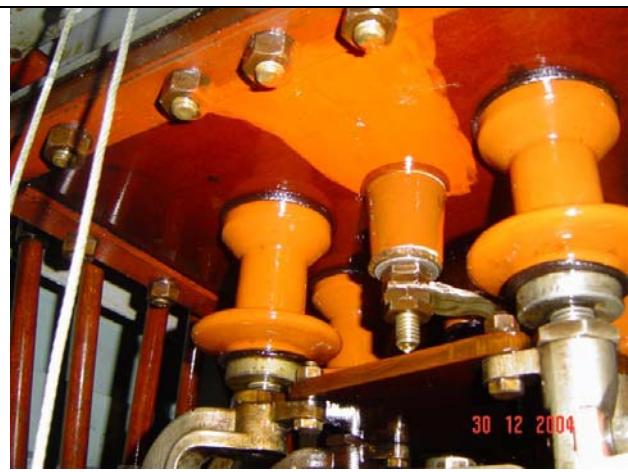
Figure 23: Barrier board and insulator after repairs

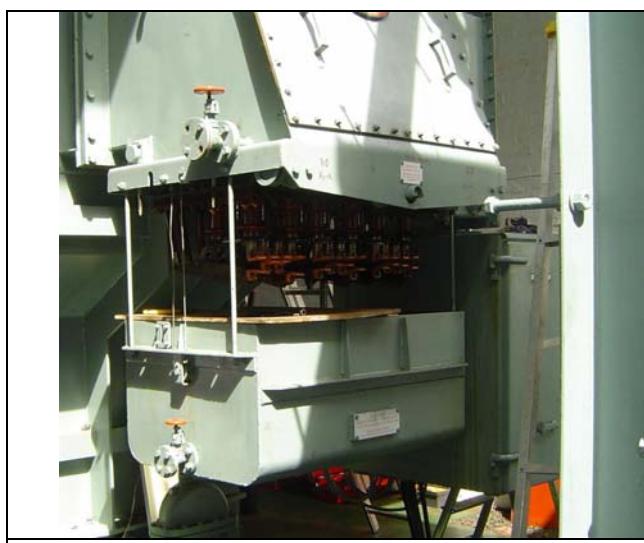
The selector and diverter are housed in separate compartments, see **Figure 24**. Visual inspections of these items were performed. The tap changer was operated throughout the tapping range to check for mechanical problems. No defects were noted apart from burns on the arcing contacts in the diverter, and since these contacts were made of only copper and not copper-tungsten tipped as would be the case for arcing contacts, it was initially thought that the burn marks were normal wear and tear, see **Figure 25**. There were no other visible signs to indicate a fault in the tap changer. The contacts were lightly dressed, diverter filled with oil, and made ready for testing.

Figure 24: Diverter shown opened below and

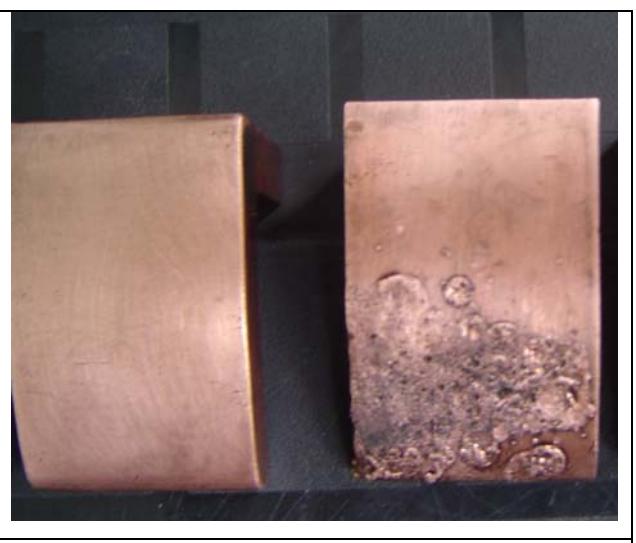
Figure 25: Diverter contacts

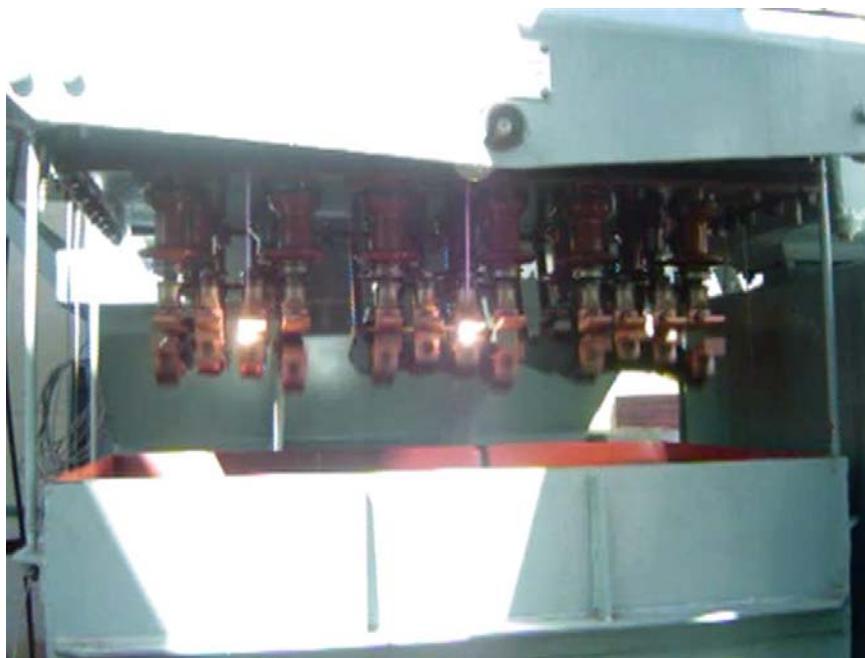
When the test was performed, the exciting current was relatively high as per the previous tests. At some tapping points the current rose beyond the instrument limit and no reading were obtained. The diverter compartment was then opened and the tests repeated. Significant arcing was observed during the transition period, as shown in **Figure 26**. It was then suspected that there was a break-before-make condition. This was, however, not visible due to the high speed operation. To confirm this, the operating rod was disconnected from the mechanism box and a slow close performed. The suspicion was confirmed- it was found that there was indeed a break-before-make condition. There were various possible reasons why this happened. A sister transformer was then inspected to ascertain the required operating process, and this transformer contacts were adjusted accordingly. The exciting current tests were performed once more, and the test was successful. The transformer was subsequently commissioned.

Figure 26: Arcing in diverter during exciting current test
