## RADIO FREQUENCY INTERFERENCE MEASUREMENTS AS A HV PLANT DIAGNOSTIC TOOL

Kamendren Govender  
Doble Engineering Africa

### ABSTRACT

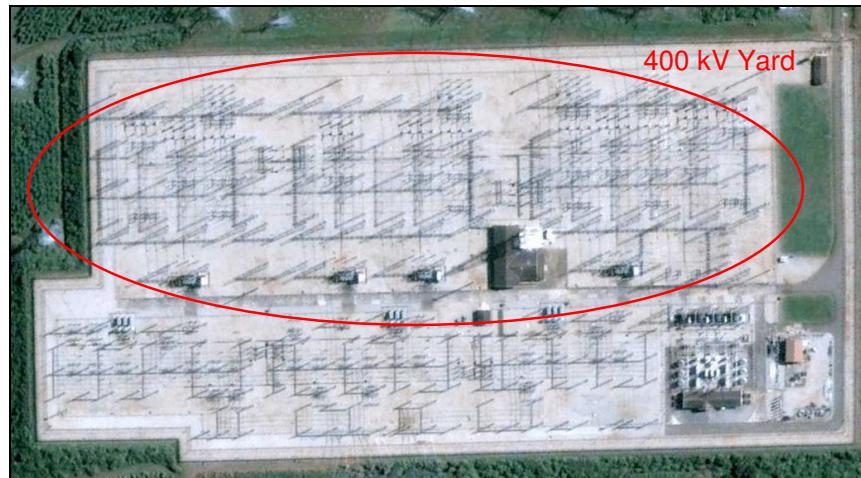
The substation discussed below has a capacity of 2000MW and was commissioned in 1995. An aerial photograph of the substation is shown in Figure 2 with the 400 kV yard encircled. The photograph illustrates both the size and complexity of the site.

**Figure 2: Aerial View of Substation ongoing RFI Surveillance**

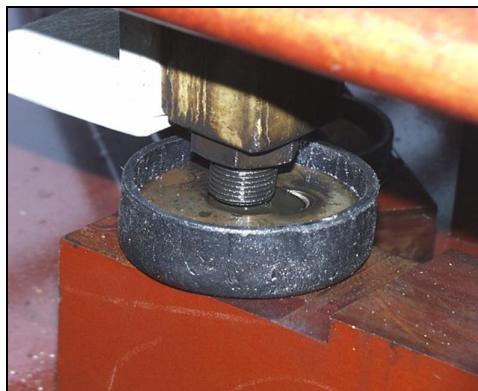
With both the DGA and RFI analysis pointing toward a discharge type fault, the go-ahead to perform an internal inspection was granted. The inspection revealed a winding clamping bolt sparking fault, thereby confirming the floating potential fault as described above. See Figure 12.

**Figure 12: The source of the PD from Winding Clamping Bolt**
