TRANSFORMER FLEET MANAGEMENT THE CITY POWER EXPERIENCE

by
S Xulu, City Power
and

Luwendran Moodley and Kamendren Govender, Doble Engineering Africa

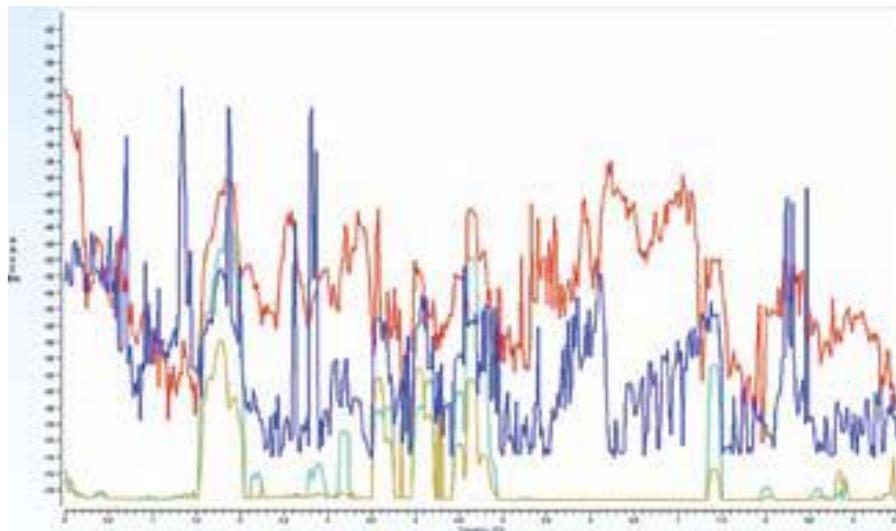
Figure 3: PD scan

RFI signals from discharge activity are considered to be broadband and impulsive in nature with low repetition rates. Spectrum analyzers and EMI scanning receivers are widely available and used in detection and measurement of RFI signals. However, their use for measuring low repetition rate broadband signals presents particular challenges for reliable and repeatable detection and measurement. The measurement process requires specific understanding of signal and instrument characteristics to ensure the RFI signals are accurately represented. Surveillance of RFI emissions from PD phenomena involves the measurement of complex waveforms varying considerably and often erratically in amplitude and time. Research and practical measurement carried out on PD activity within oil-insulated HV equipment demonstrates that discharges produce current pulses with rise times less than 1 ns and therefore capable of exciting broadband signals in the VHF (30 to 300 MHz) and UHF (300 MHz to 3 GHz) bands. Other investigations in open-air insulation substations show that signals from PD and flashover occupy a frequency range up to 300 MHz.

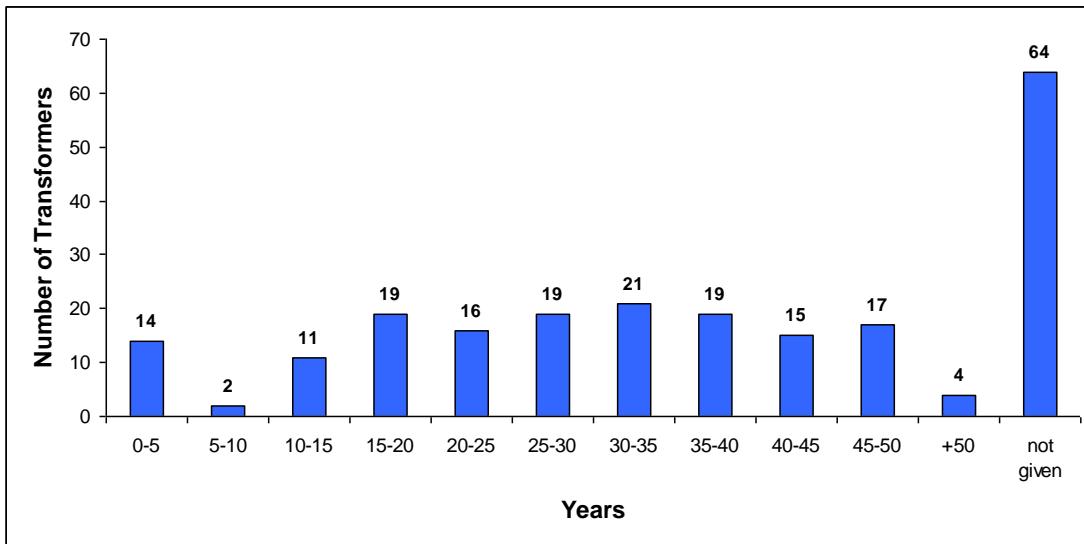
Figure 6: Transformer Age Distribution

The treatment of transformers by age is a matter of owner's internal policy. The age of a transformer can have a number of factors including the effect on the mechanical strength of the transformer's insulation and hence its ability to withstand common short circuit forces that are inherent in a transmission system. A further consideration is the relationship between advanced paper aging and transformer age. The relationship between the age of the transformer and its performance is a subject of great uncertainty. However, coupled with the other factors listed here the transformer's age can play an importance role in risk decision. It is common knowledge that transformers built and designed in the past have proven to be highly reliable with a low failure rate for many decades. The introduction of advanced computer programming for design purposes have resulted in modern transformers having a low loading capability. However, it is noticed that older transformers may lack adequate provision for leakage flux and have a higher probability of localized thermal problems. Further, industry standards (IEC and IEEE) were revised to ensure greater short circuit duty for modern transformers.

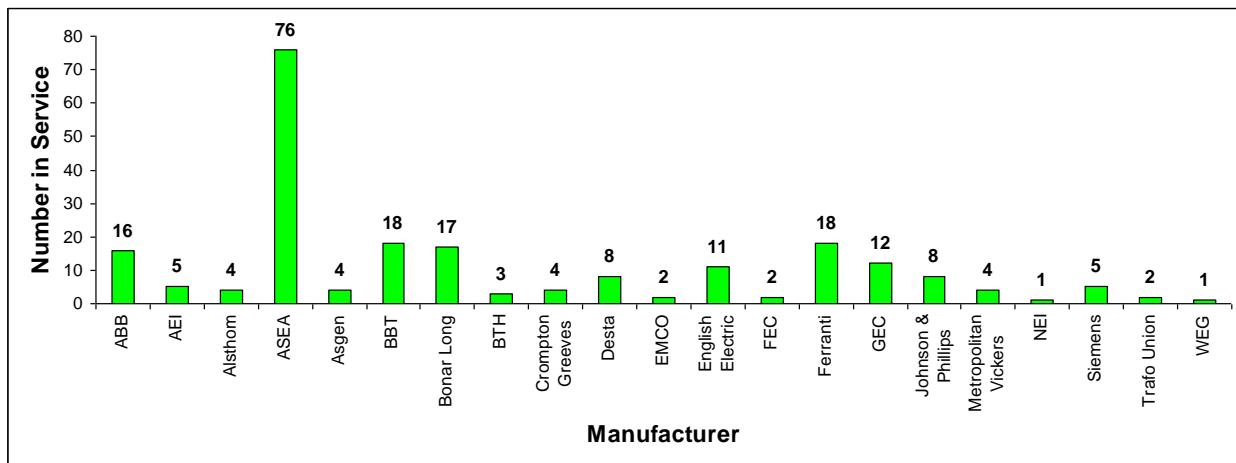
Figure 7: Transformer Manufacturers

The place of manufacture and the manufacturer is a key indicator of quality related issues. The identification of dominating deterioration and failure modes for each design group/manufacturer can be used to identify the optimum diagnostic strategy to reveal the onset of failure modes.

Transformers of the same manufacturer and of same design (based on the serial numbers) have shown to have common fault characteristics. They are as follows.

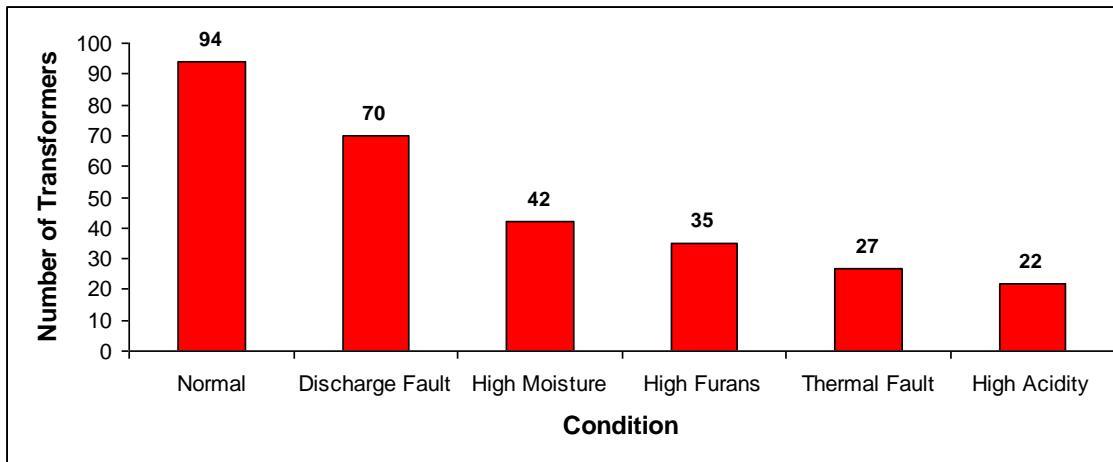
Figure 8: Transformer Condition Classification

Figure 3 below illustrated the difference faults that are considered to increase the risk of a transformer failure.

All transformers were placed into the following condition classifications
